Keithley Instruments
28775 Aurora Road
Cleveland, Ohio 44139-1891
1-800-935-5595
www.tek.com/keithley

Version v1.6.5b Release

Version 1.6.5b is an audited minor release which fixes one bug listed below.
[RELEASED 24-OCT-2017](#)

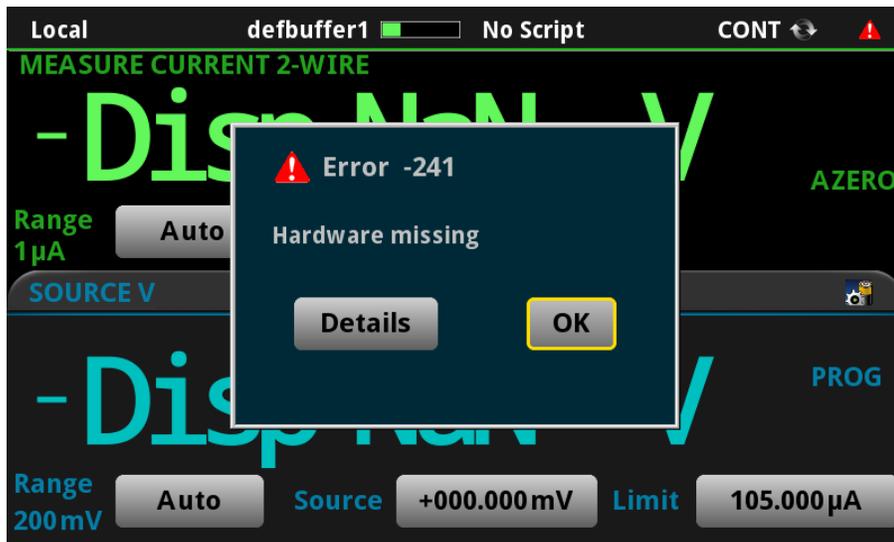
PR61502 From a cold power up, the Model 2461 SMU will sometimes fail with the following error message and will not operate properly.

If this issue occurs, a subsequent power cycle will allow the instrument to power up properly.

This issue has been corrected with firmware revision v.1.6.5.
