Oregon State University Solar Vehicle Team: Troubleshooting Three Phase Permanent Magnet AC Motor Using Tektronix MSO2024 Oscilloscope

Simon Crocker, Wilkins White,
Oregon State University Solar Vehicle Team Members

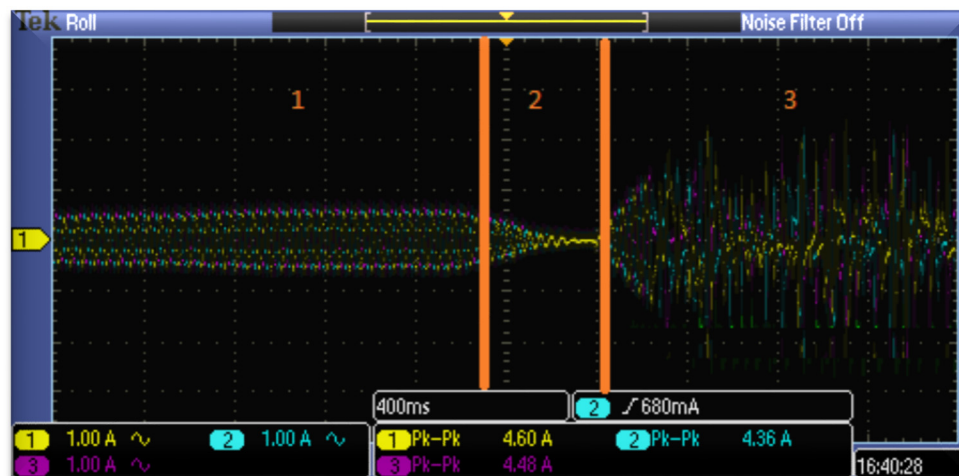
In 2013, the team's motor began having problems with commutation and torque production. When high torque was commanded by the accelerator the motor would have mechanical torque pulsations and highly audible vibrations described by the drivers as a loud "ka-chunka-chunka-chunka." This also happened when reverse torque was demanded during regenerative braking. The Tektronix MSO2024 oscilloscope was used to determine that the fault occurred during high motor current events when noise began to affect the hall-effect signals used for commutation.

FIGURE 3: MOTOR BEHAVIOR DURING NORMAL OPERATION (1), NON-REGEN BRAKING (2), AND HIGH TORQUE DEMAND (3). CHANNELS 1-3 ARE MEASURING THE CURRENT IN THE POWER LINE OF EACH PHASE.

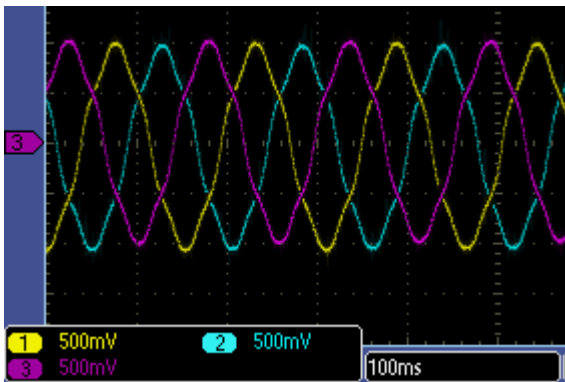
FIGURE 8: NORMAL BACK EMF. PROBES 1-3 ARE MEASURING THE VOLTAGE BETWEEN EACH PHASE (V_{AB} , V_{BC} , V_{AC})

To rule out mechanical issues as a source of the problem, the motor was disassembled, physically examined, and the bearings replaced. After this, the team tested the motor's back EMF. To do this the team detached the motor from the motor controller and connected voltage probes to the power line of each phase. The motor was then manually spun to induce a magnetic field in the stator which in turn produced voltage waveforms that could then be read by the MSO2024 (Figure 7). The resulting waveforms (Figure 8) indicated that the permanent magnets were good and this was not a mechanical issue. Next, the team examined the motor phase currents to check for hard shorts in the stator windings; however normal current waveforms ruled out that possibility (Figure 9).

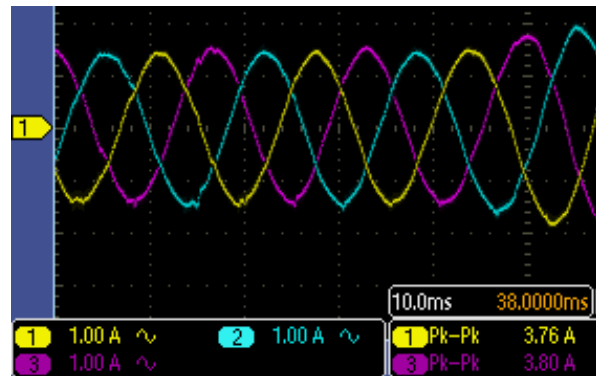
FIGURE 9: NORMAL MOTOR CURRENT. PROBES 1-3 ARE CONNECTED TO EACH MOTOR PHASE

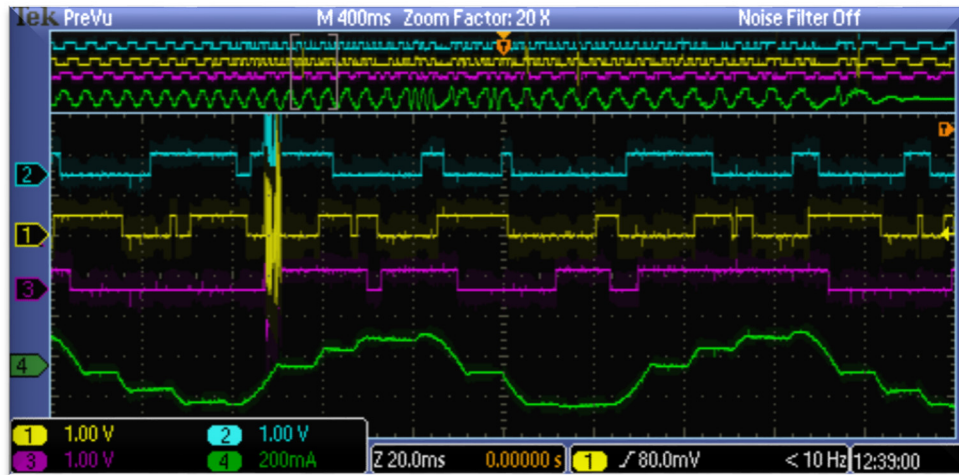
With mechanical issues ruled out, the team moved on to examine the hall-effect signals which serve as magnetic encoders for commutation. Testing under normal driving conditions showed that the hall-effect waveforms would deform wildly during motor events (Figure 10). To determine if there was an issue with the hall-effect sensors themselves the team examined each hall-effect output signal as the motor was manually spun. Even at relatively high speeds the hall-effect waveforms were perfectly formed (Figure 11), indicating that the hall-effect issue was a symptom, not a cause.

FIGURE 10: ERRATIC HALL EFFECT SIGNALS DURING MOTOR EVENTS. PROBES 1-3 ARE CONNECTED TO THE HALL-EFFECT SIGNAL LINES WHILE PROBE 4 SHOWS THE PHASE CURRENT.

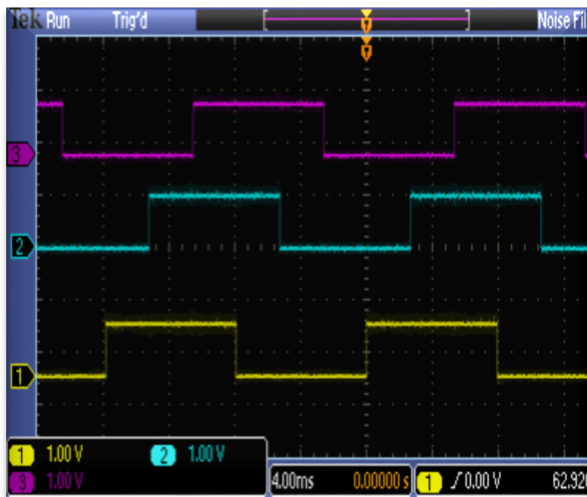
FIGURE 11: HALL EFFECT SIGNALS WHEN MOTOR WAS MANUALLY SPUN

In order to gain a close up look at the observed behavior, the team utilized the MSO024's ability to capture data over a relatively large time interval and zoom in to time spans of 0.2 seconds. Comparing the waveforms while the motor was being manually spun (Figure 11) and waveforms while the motor was being powered (Figure 12) revealed significant noise in the hall-effect sensor output during normal operation. The team prototyped a low-pass filter (Figure 13) and placed it on the hall-effect output to try and reduce the noise.

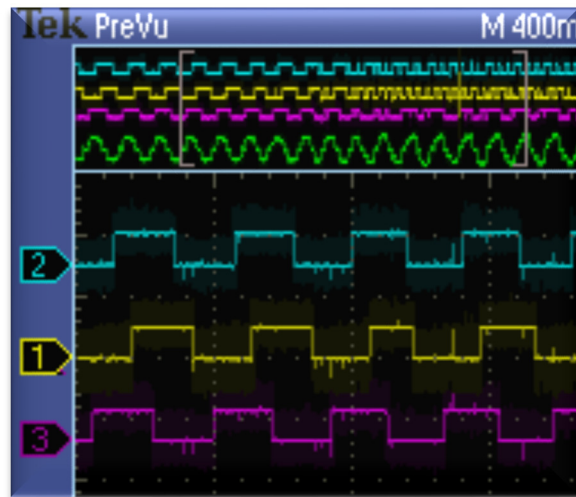
FIGURE 12: HALL EFFECT SIGNALS WITH MOTOR POWERED UNDER NORMAL DRIVING CONDITIONS

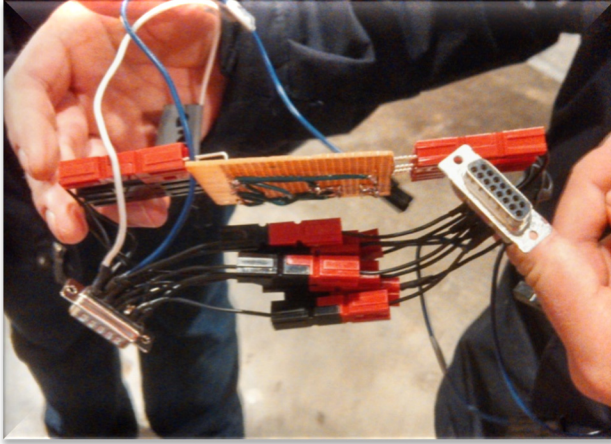
FIGURE 13: LOW PASS FILTER TO ELIMINATE HALL EFFECT SIGNAL NOISE

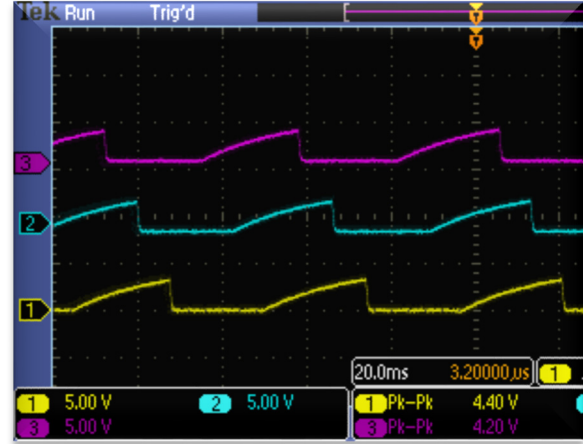
FIGURE 14: CHARGE DELAY DUE TO LOW PASS FILTER ON HALL EFFECT SIGNAL LINE

The low pass filter successfully attenuated the excess noise which noticeably improved the motor's operation. However the filter introduced an undesirable side effect. The time delay caused by the charging capacitors (Figure 14) caused the motor to behave erratically and ultimately rendered the solution ineffective. With the promising results from the low-pass filter it was suspected that there may be noise on the hall-effect power input. To test this theory, decoupling capacitors were installed on each hall-effect power line to filter the DC power signal and attenuate the noise while avoiding issues caused by an in-series filter. Further testing showed a marked improvement with only small capacitor values, and additional parallel capacitance solved the issue entirely.
