Keithley Instruments
28775 Aurora Road
Cleveland, Ohio 44139
1-800-935-5595
tek.com/keithley

Model 2461 System SourceMeter™

VERSION 1.7.1 RELEASE

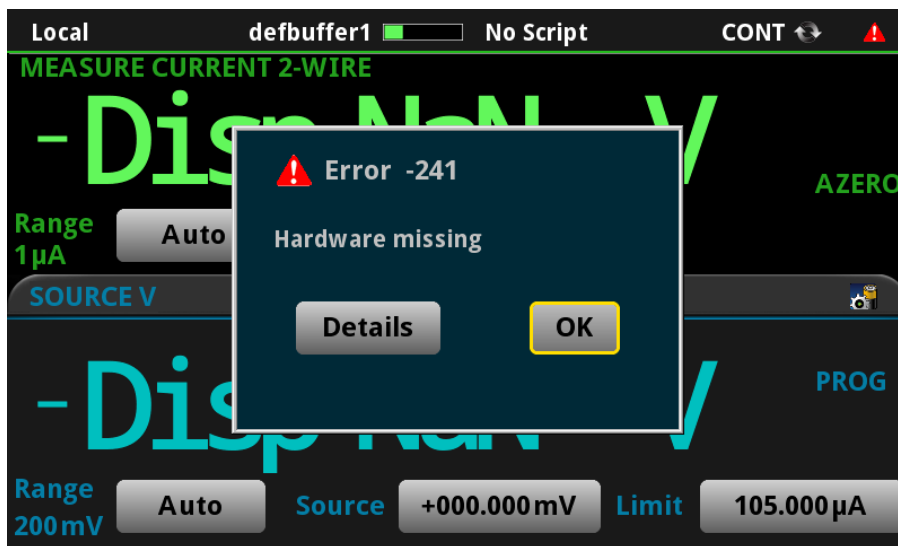
PR61502 From a cold power up, the Model 2461 SMU will sometimes fail with the following error message and will not operate properly.

If this issue occurs, a subsequent power cycle will allow the instrument to power up properly.

This issue has been corrected with firmware revision v.1.6.5.
