Model DMM7510 7½ Digit Graphical Multimeter

Version 1.6.3d Firmware Release Notes

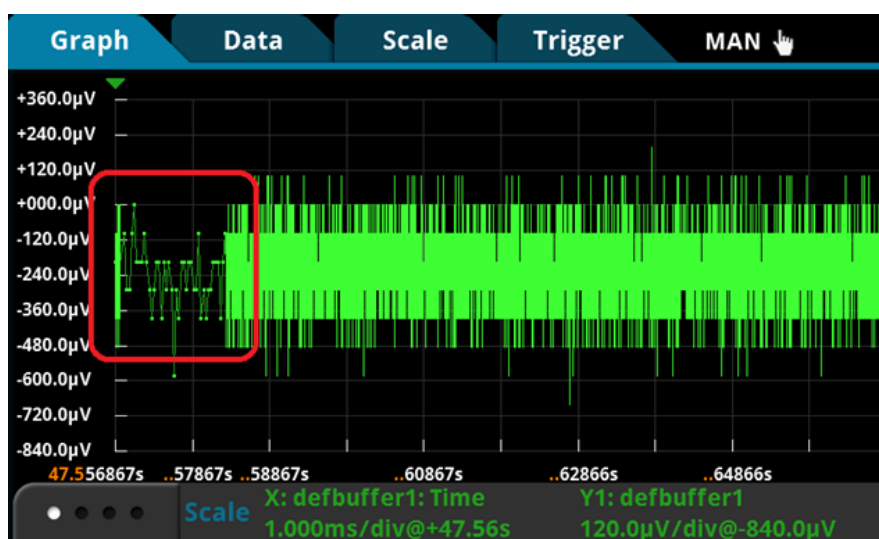
PR54974, UI graph occasionally appears to be missing digitizer data
PR54934

When using the UI to view bursts of digitizer data on the graph, you may see areas that appear to have missing data. See the example in the image below. Even though data is being sampled consistently throughout the viewable range, it appears as though fewer points are available in the circled area.

This may only occur when more than 5,000 points are visible on the graph at once and sample rates exceed 50k.

Pan or scale the graph by touching it to force a refresh. All data will appear. The measurements were taken and are in the buffer.
