Model DMM7510 7½ Digit Graphical Multimeter

Version 1.0.0h Firmware Release Notes

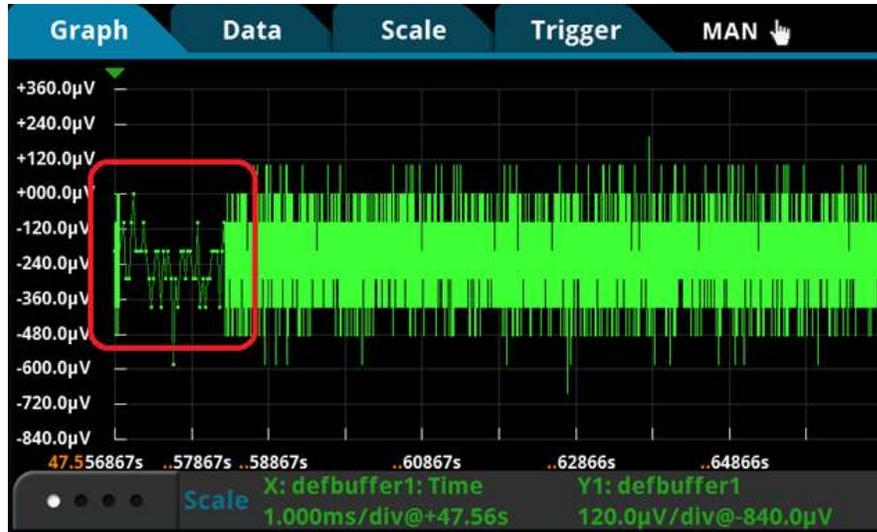
PR54974, UI graph occasionally appears to be missing digitizer data
PR54934

When using the UI to view bursts of digitizer data on the graph, you may see areas that appear to have missing data. See the example in the image below. Even though data is being sampled consistently throughout the viewable range, it appears as though fewer points are available in the circled area.

This may only occur when more than 5,000 points are visible on the graph at once and sample rates exceed 50k.

Pan or scale the graph by touching it to force a refresh. All data will appear. The measurements were taken and are in the buffer.
