# Series 3700A System Switch/Multimeter

## Version 1.53 Firmware Release Notes

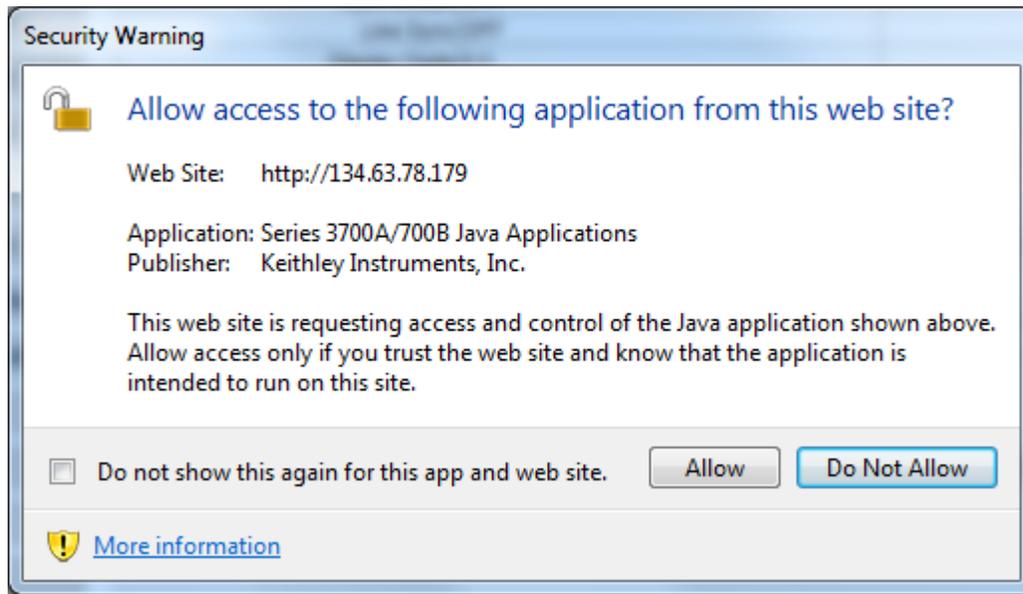
**PR51964 Models affected:**

When switching from one web application to another for the first time, a Java security warning window similar to the one shown below is used to get the user's permission. In the most recent version of Java (7u65 an 8u11), the security warning window appears **behind** the web browser when using Internet Explorer. Until the security warning window is acknowledged, the web browser will appear to be unresponsive. This only happens with Internet Explorer.

Enable the "Do not show this again for this app and web site." check-box prior to clicking the "Allow" button.
