Version 1.7.1 Firmware Release Notes**CONTENTS**

Model 2450 Interactive SourceMeter™ Instrument, 2450-NFP, 2450-RACK, 2450-NFP-RACK

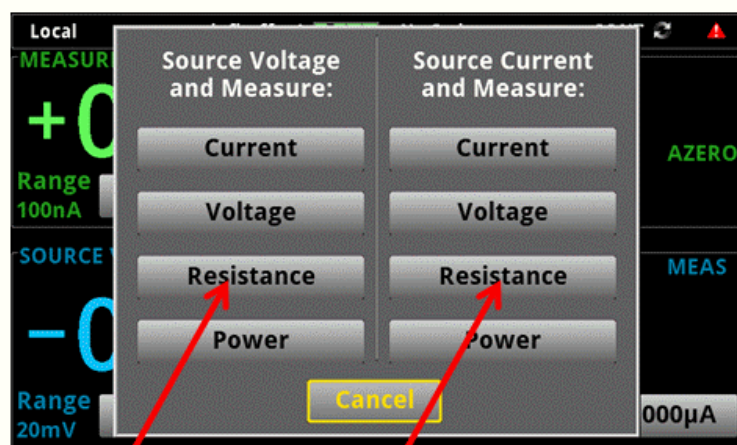
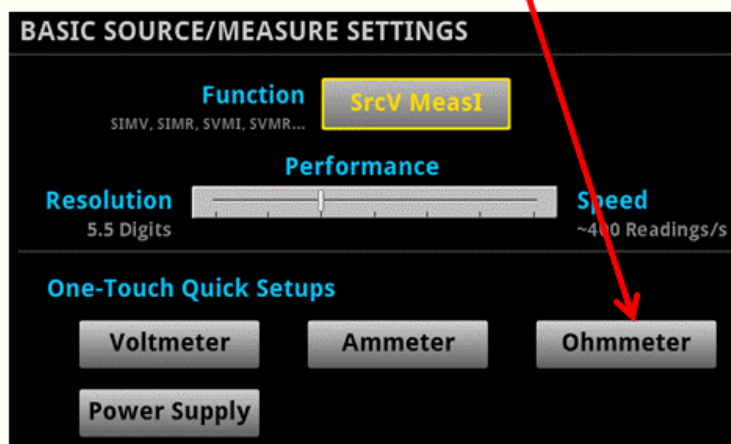
h. Front panel user interface setting of Manual vs. Auto Ohms measurements

Both exhibit "Manual" Ohms behavior
(works just like Power by setting units to Ohms and going to SVMI or SIMV)

Exhibits "Auto" Ohms behavior
