Keithley Instruments  
28775 Aurora Road  
Cleveland, Ohio 44139  
1-800-935-5595  
[tek.com/keithley](http://tek.com/keithley)

## Version 1.6.7c Firmware Release Notes

2450, 2450-NFP, 2450-RACK, 2450-NFP-RACK

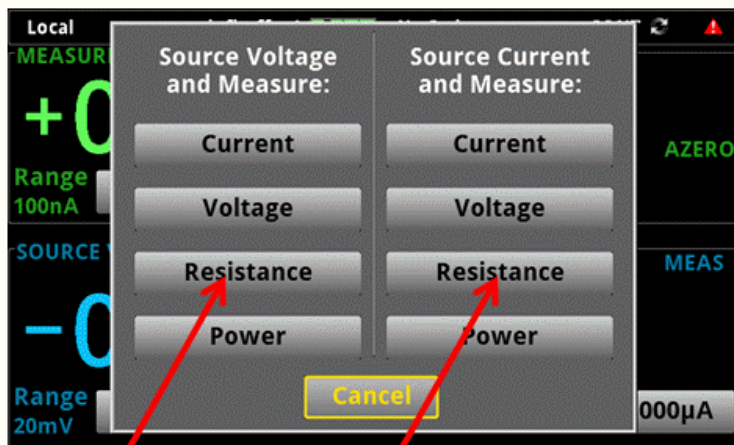
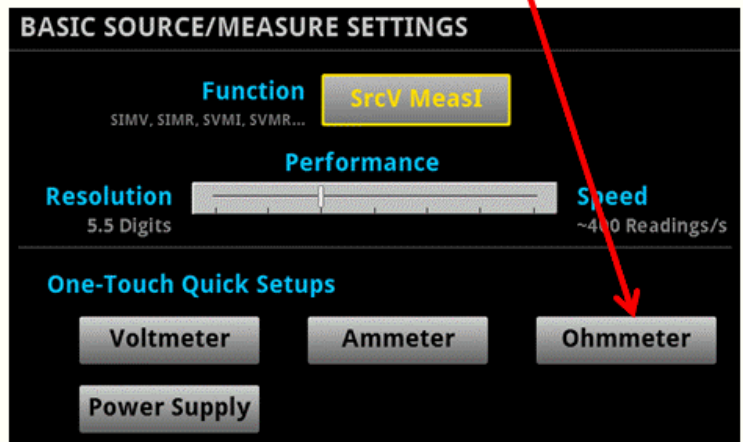
h. Front panel user interface setting of Manual vs. Auto Ohms measurements

<see the following figure for details>

Exhibits "Auto" Ohms behavior
