Keithley Instruments
28775 Aurora Road
Cleveland, Ohio 44139
1-800-935-5595
tek.com/keithley

Model 2460 High-Current Interactive SourceMeter® Instrument
2460-NFP
2460-RACK
2460-NFP-RACK

VERSION 1.7.0 RELEASE

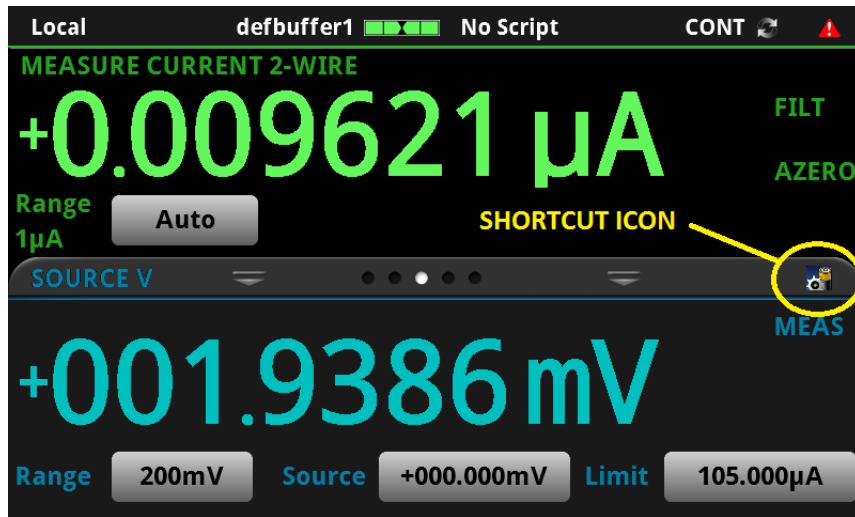
Add a direct shortcut from the HOME view measurement line to the measurement settings menu.

A shortcut icon has been added to the swipe bar on the HOME source/measurement tab.
