# 2460 High-Current Interactive SourceMeter

## Version 1.7.18 Firmware Release Notes

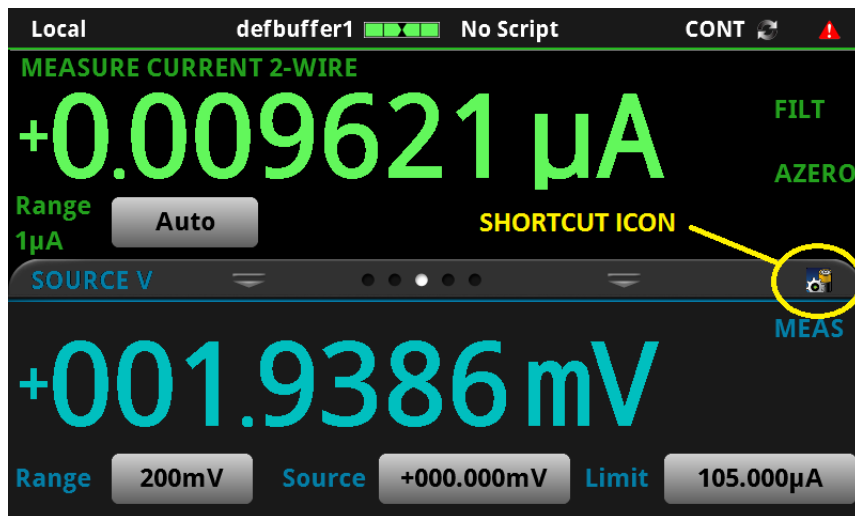
Add a direct shortcut from the HOME view measurement line to the measurement settings menu.

A shortcut icon has been added to the swipe bar on the HOME source/measurement tab.
