Keithley Instruments
28775 Aurora Road
Cleveland, Ohio 44139
1-800-935-5595
tek.com/keithley

- Model 2460 High-Current Interactive SourceMeter™
- Instrument 2460-NFP
- 2460-RACK
- 2460-NFP-RACK

VERSION 1.7.1 RELEASE

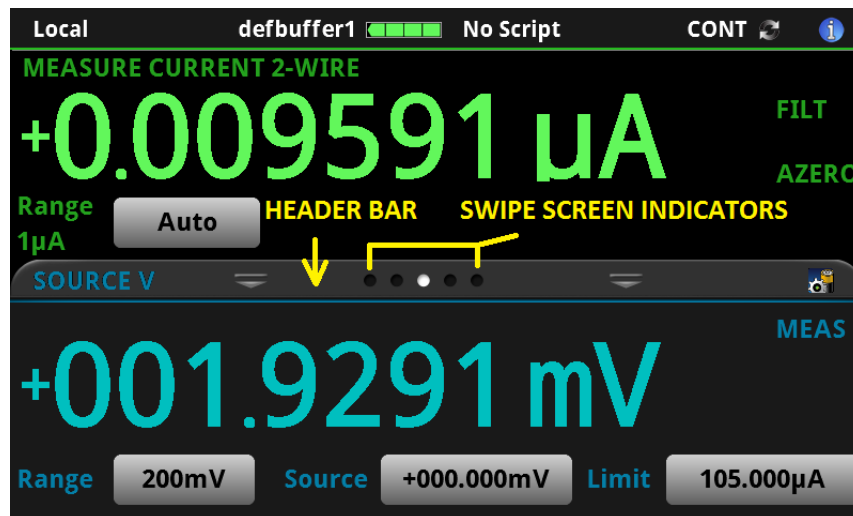
- e. Swipe Down on the Home screen will display larger readings.
4. Tabs and Buttons: Throughout the user interface multiple data display options have been made available through tabs (header bars) with swipe screen indicators to show how many different display options are available and which display tab is active.
