Keithley Instruments  
28775 Aurora Road  
Cleveland, Ohio 44139  
1-800-935-5595  
[tek.com/keithley](http://tek.com/keithley)

- Model 2460 High-Current Interactive SourceMeter™ Instrument
- 2460-NFP
- 2460-RACK
- 2460-NFP-RACK

## VERSION 1.7.2 RELEASE

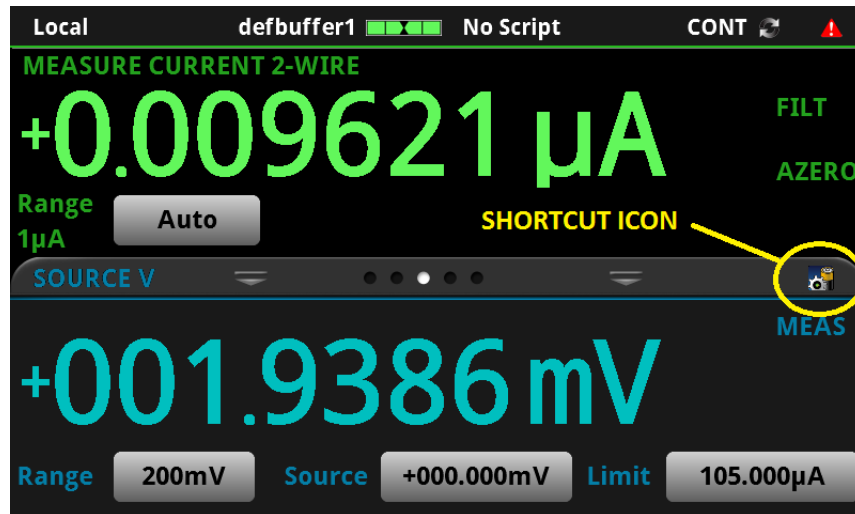
Add a direct shortcut from the HOME view measurement line to the measurement settings menu.

A shortcut icon has been added to the swipe bar on the HOME source/measurement tab.
