- Model 2460 High-Current Interactive SourceMeter® Instrument
- 2460-NFP
- 2460-RACK
- 2460-NFP-RACK

## VERSION 1.7.5 RELEASE

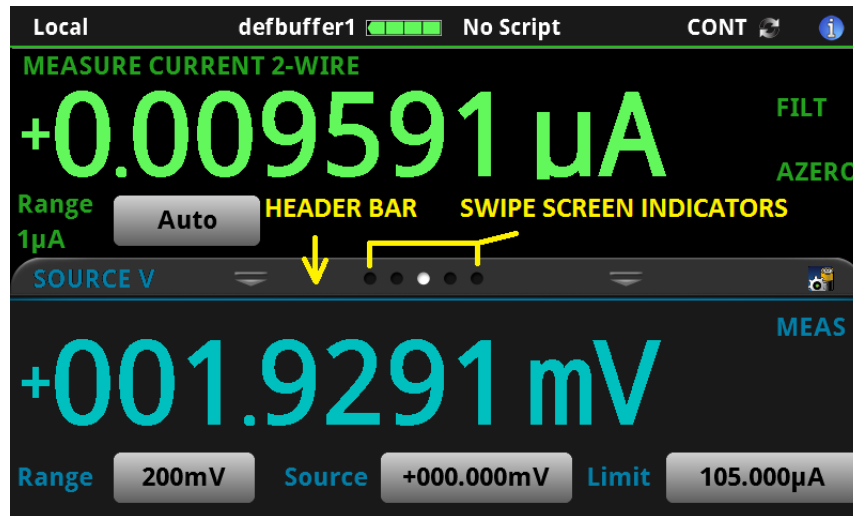
4. Tabs and Buttons: Throughout the user interface multiple data display options have been made available through tabs (header bars) with swipe screen indicators to show how many different display options are available and which display tab is active.
