Keithley Instruments
28775 Aurora Road
Cleveland, Ohio 44139
1-800-833-9200
tek.com/keithley

- Model 2460 High-Current Interactive SourceMeter® Instrument
- 2460-NFP
- 2460-RACK
- 2460-NFP-RACK

VERSION 1.7.7 RELEASE

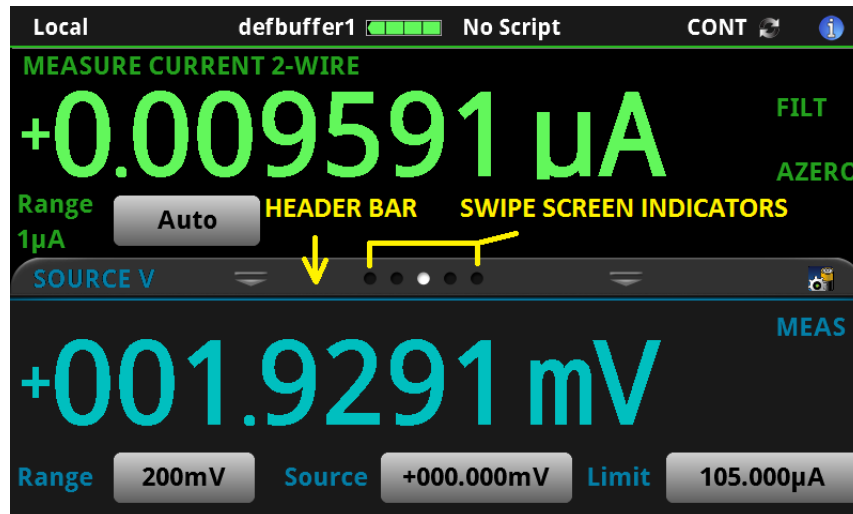
4. Tabs and Buttons: Throughout the user interface multiple data display options have been made available through tabs (header bars) with swipe screen indicators to show how many different display options are available and which display tab is active.
