Keithley Instruments, Inc.
28775 Aurora Road
Cleveland, Ohio 44139-1891
1-888-KEITHLEY
www.keithley.com

Version v1.6.1a Release

Version v1.6.0i Release

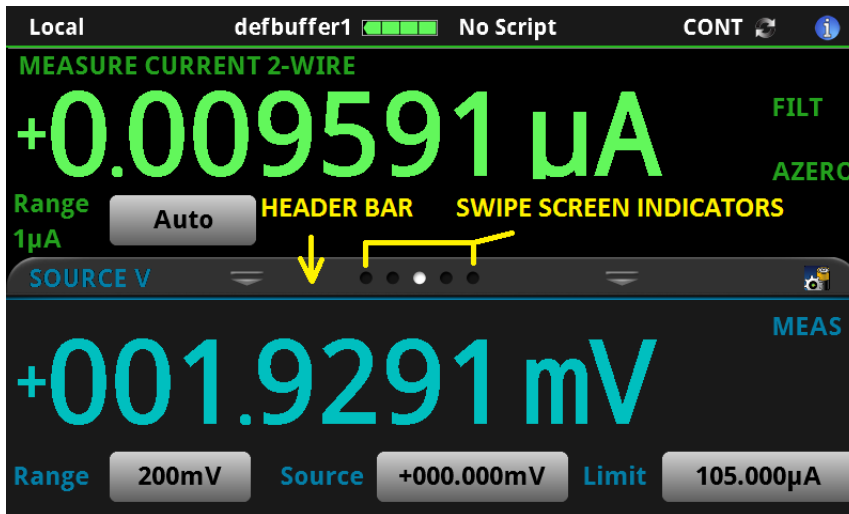
- e. Swipe Down on the Home screen will display larger readings.
4. Tabs and Buttons: Throughout the user interface multiple data display options have been made available through tabs (header bars) with swipe screen indicators to show how many different display options are available and which display tab is active.

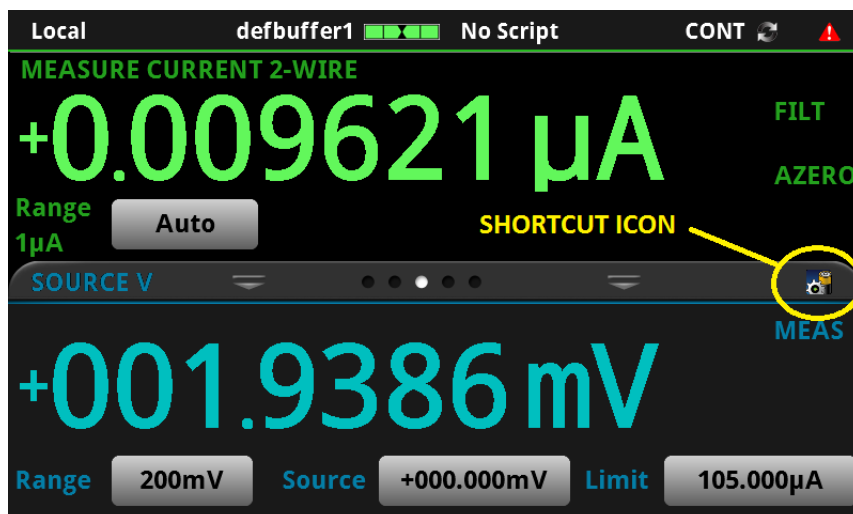
Add a direct shortcut from the HOME view measurement line to the measurement settings menu.

A shortcut icon has been added to the swipe bar on the HOME source/measurement tab.
