## GENERAL INFORMATION

This firmware is used on the following Keithley Instruments product models:

- Model 2461 High-Current SourceMeter® Instrument
- 2461-NFP
- 2461-RACK
- 2461-NFP-RACK

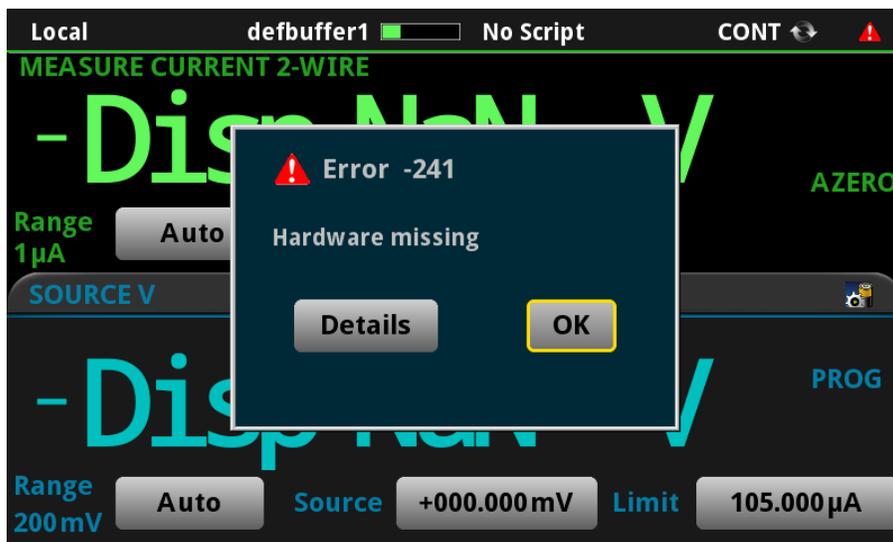
PR61502 From a cold power up, the Model 2461 SMU will sometimes fail with the following error message and will not operate properly.

If this issue occurs, a subsequent power cycle will allow the instrument to power up properly.

This issue has been corrected with firmware revision v.1.6.5.
