Model 2461 High-Current SourceMeter® Instrument
2461-NFP
2461-RACK
2461-NFP-RACK

VERSION 1.7.12 RELEASE

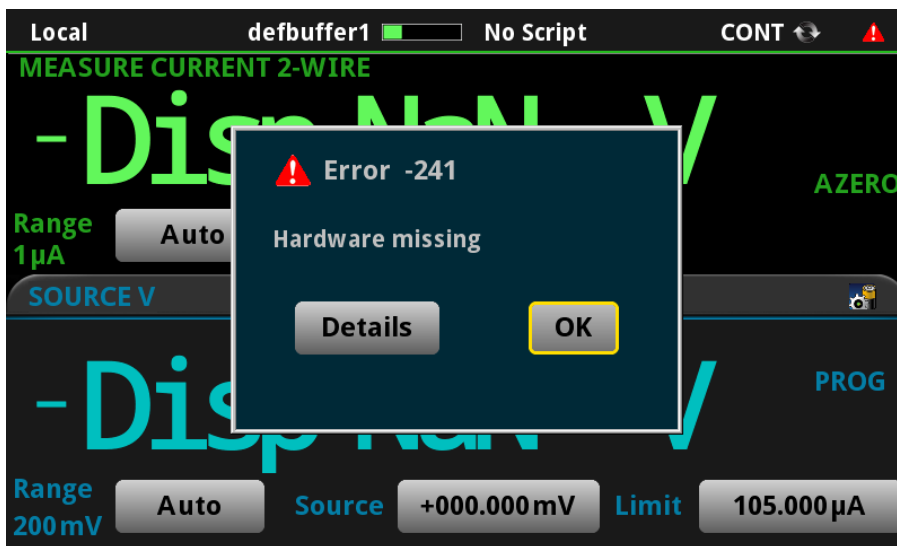
PR61502 From a cold power up, the Model 2461 SMU will sometimes fail with the following error message and will not operate properly.

If this issue occurs, a subsequent power cycle will allow the instrument to power up properly.

This issue has been corrected with firmware revision v.1.6.5.
