Keithley Instruments
28775 Aurora Road
Cleveland, Ohio 44139
1-800-833-9200
tek.com/keithley

SUPPORTED MODELS

- Model 2461 High-Current SourceMeter® Instrument
- 2461-NFP
- 2461-RACK
- 2461-NFP-RACK

VERSION 1.7.5 RELEASE

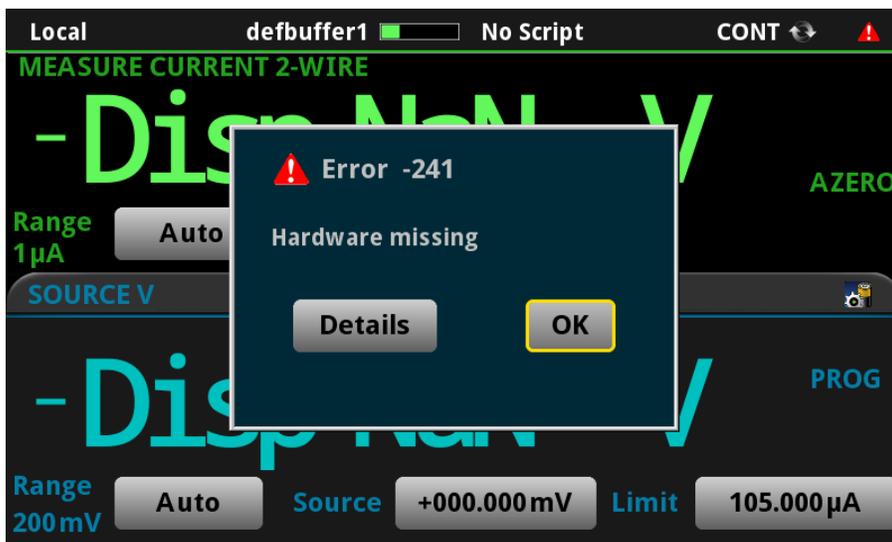
PR61502 From a cold power up, the Model 2461 SMU will sometimes fail with the following error message and will not operate properly.

If this issue occurs, a subsequent power cycle will allow the instrument to power up properly.

This issue has been corrected with firmware revision v.1.6.5.
