# Series 3700A System Switch/Multimeter

## Version 1.54 Firmware Release Notes

**Keithley Instruments**  
28775 Aurora Road  
Cleveland, Ohio 44139-1891  
1-888-KEITHLEY  
www.keithley.com

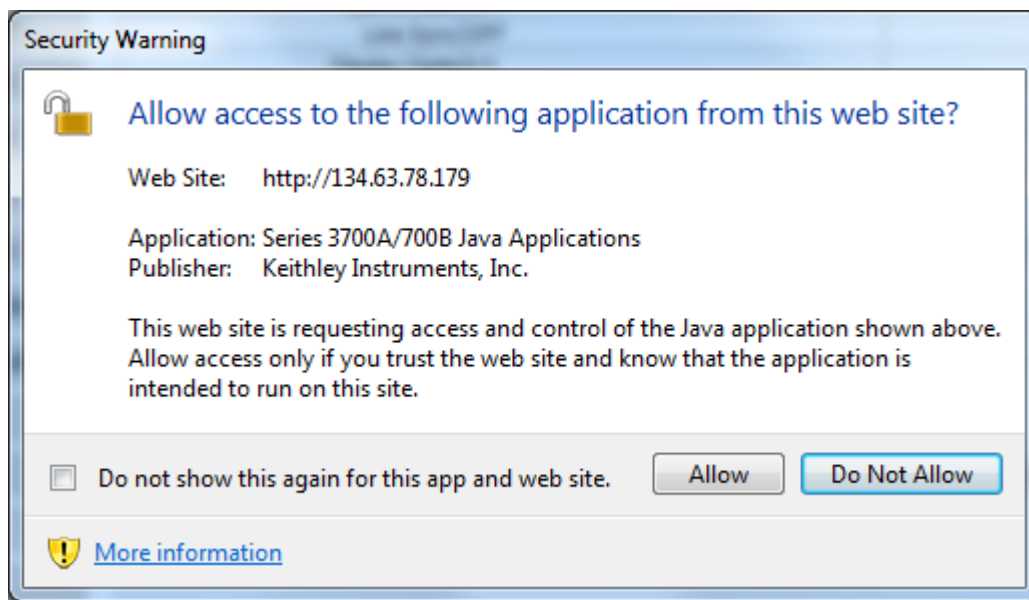
PR51964 **Models affected:**

When switching from one web application to another for the first time, a Java security warning window similar to the one shown below is used to get the user's permission. In the most recent versions of Java (7u65 and 8u11), the security warning window appears **behind** the web browser when using Internet Explorer. Until the security warning window is acknowledged, the web browser will appear to be unresponsive. This only happens with Internet Explorer.

Enable the "Do not show this again for this app and web site." check-box prior to clicking the "Allow" button.
