Keithley Instruments
28775 Aurora Road
Cleveland, Ohio 44139-1891
1-888-KEITHLEY
www.keithley.com

Models 3706A, 3706A-S, 3706A-NFP, 3706A-SNFP, and all Series 3700 cards.

Version 1.55 Release

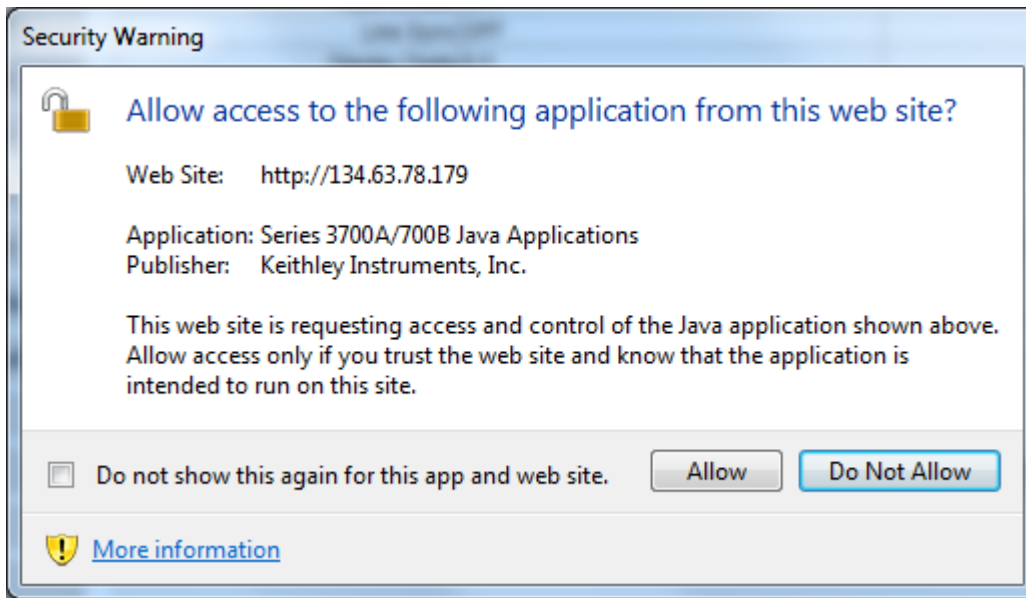
PR51964 **Models affected:**

When switching from one web application to another for the first time, a Java security warning window similar to the one shown below is used to get the user's permission. In the most recent versions of Java (7u65 and 8u11), the security warning window appears **behind** the web browser when using Internet Explorer. Until the security warning window is acknowledged, the web browser will appear to be unresponsive. This only happens with Internet Explorer.

Enable the "Do not show this again for this app and web site." check-box prior to clicking the "Allow" button.
