A Tektronix Company

Series 3700A System Switch/Multimeter

Version 1.57 Firmware Release Notes

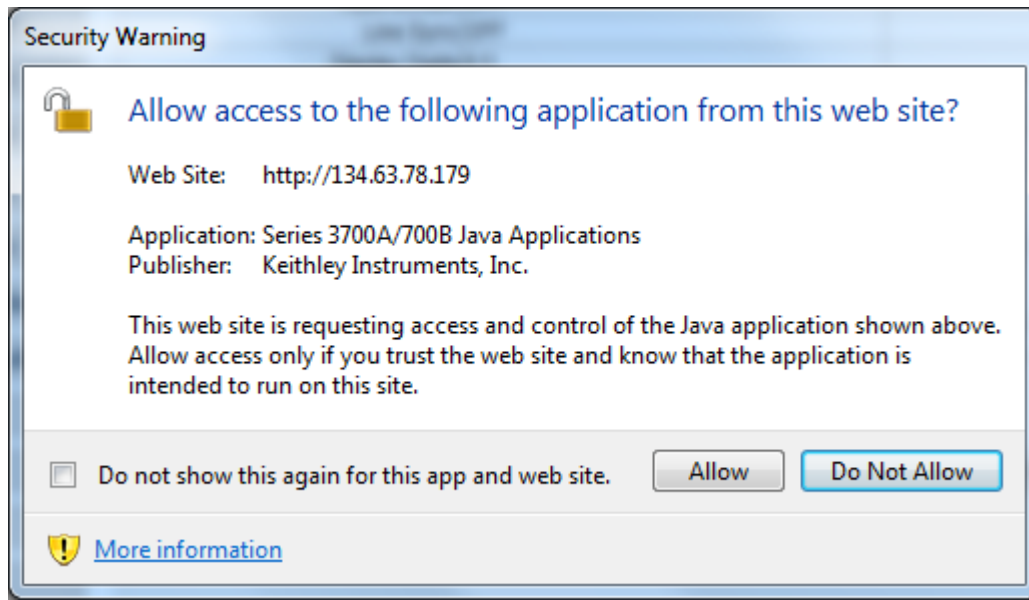
PR51964 Models affected:

When switching from one web application to another for the first time, a Java security warning window similar to the one shown below is used to get the user's permission. In the most recent versions of Java (7u65 and 8u11), the security warning window appears **behind** the web browser when using Internet Explorer. Until the security warning window is acknowledged, the web browser will appear to be unresponsive. This only happens with Internet Explorer.

Enable the "Do not show this again for this app and web site." check-box prior to clicking the "Allow" button.
