Model DMM7510 7½ Digit Graphical Multimeter
DMM7510-NFP
DMM7510-NFP-RACK
DMM7510-RACK

VERSION 1.7.0 RELEASE

Version 1.7.0 is a significant maintenance firmware release for the DMM7510 that brings numerous updates along with stability and reliability improvements. See the *Model DMM7510 7½ Digit Graphical Multimeter Reference Manual* (document number DMM7510-901-01) for more information.

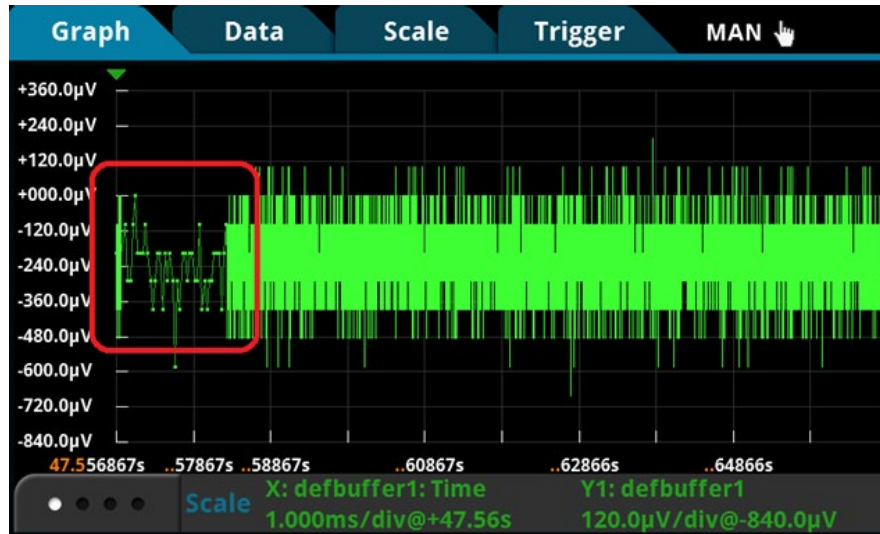
PR54974, UI graph occasionally appears to be missing digitizer data
PR54934

When using the UI to view bursts of digitizer data on the graph, you may see areas that appear to have missing data. See the example in the image below. Even though data is being sampled consistently throughout the viewable range, it appears as though fewer points are available in the circled area.

This may only occur when more than 5,000 points are visible on the graph at once and sample rates exceed 50k.

**Workaround:**

Pan or scale the graph by touching it to force a refresh. All data will appear. The measurements were taken and are in the buffer.
