Keithley Instruments
28775 Aurora Road
Cleveland, Ohio 44139
1-800-833-9200
tek.com/keithley

Model DMM7510 7½ Digit Graphical Multimeter
DMM7510-NFP
DMM7510-NFP-RACK
DMM7510-RACK

VERSION 1.7.12 RELEASE

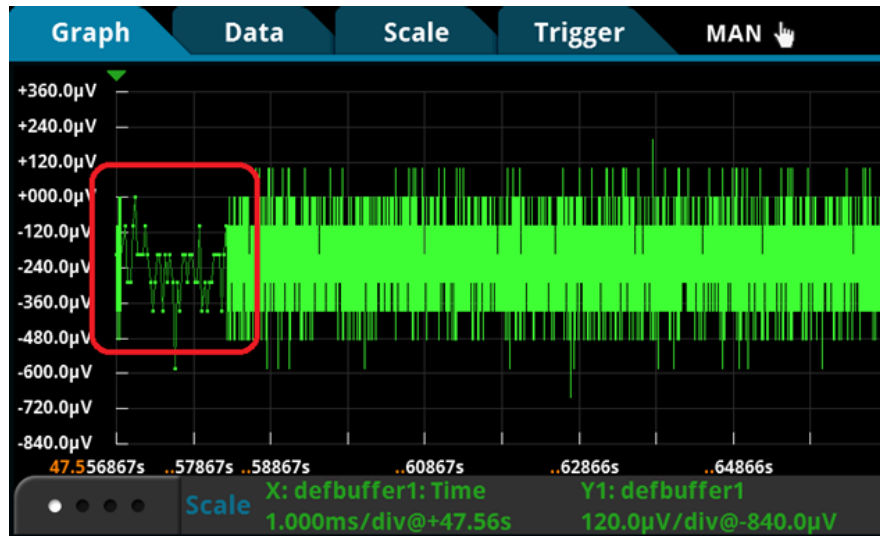
PR54974, UI graph occasionally appears to be missing digitizer data
PR54934

When using the UI to view bursts of digitizer data on the graph, you may see areas that appear to have missing data. See the example in the image below. Even though data is being sampled consistently throughout the viewable range, it appears as though fewer points are available in the circled area.

This may only occur when more than 5,000 points are visible on the graph at once and sample rates exceed 50k.

**Workaround:**

Pan or scale the graph by touching it to force a refresh. All data will appear. The measurements were taken and are in the buffer.
