Keithley Instruments  
28775 Aurora Road  
Cleveland, Ohio 44139  
1-800-833-9200  
[tek.com/keithley](http://tek.com/keithley)

Model DMM7510 7½ Digit Graphical Multimeter  
DMM7510-NFP  
DMM7510-NFP-RACK  
DMM7510-RACK

## VERSION 1.7.18 RELEASE

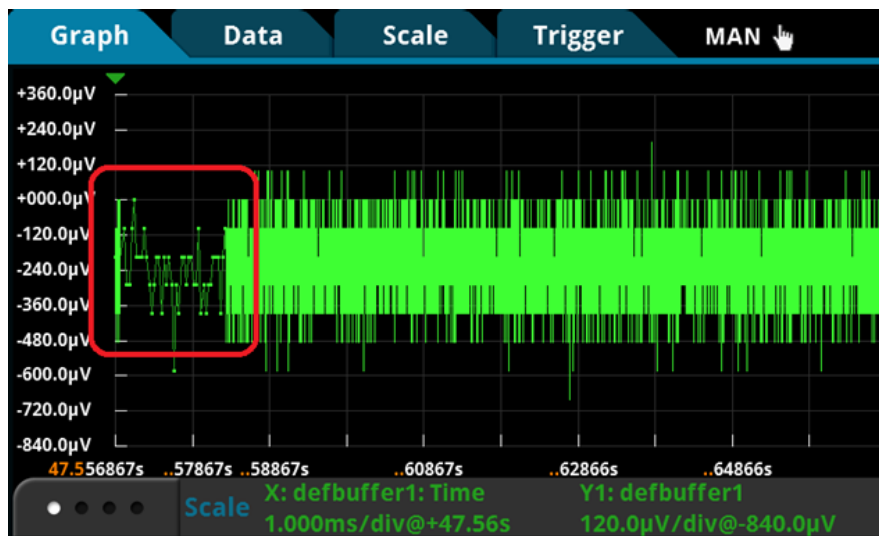
PR54974, UI graph occasionally appears to be missing digitizer data  
PR54934

When using the UI to view bursts of digitizer data on the graph, you may see areas that appear to have missing data. See the example in the image below. Even though data is being sampled consistently throughout the viewable range, it appears as though fewer points are available in the circled area.

This may only occur when more than 5,000 points are visible on the graph at once and sample rates exceed 50k.

**Workaround:**

Pan or scale the graph by touching it to force a refresh. All data will appear. The measurements were taken and are in the buffer.
