Keithley Instruments
28775 Aurora Road
Cleveland, Ohio 44139
1-800-935-5595
tek.com/keithley

Model DMM7510 7½ Digit Graphical Multimeter
DMM7510-NFP
DMM7510-NFP-RACK
DMM7510-RACK

VERSION 1.7.2 RELEASE

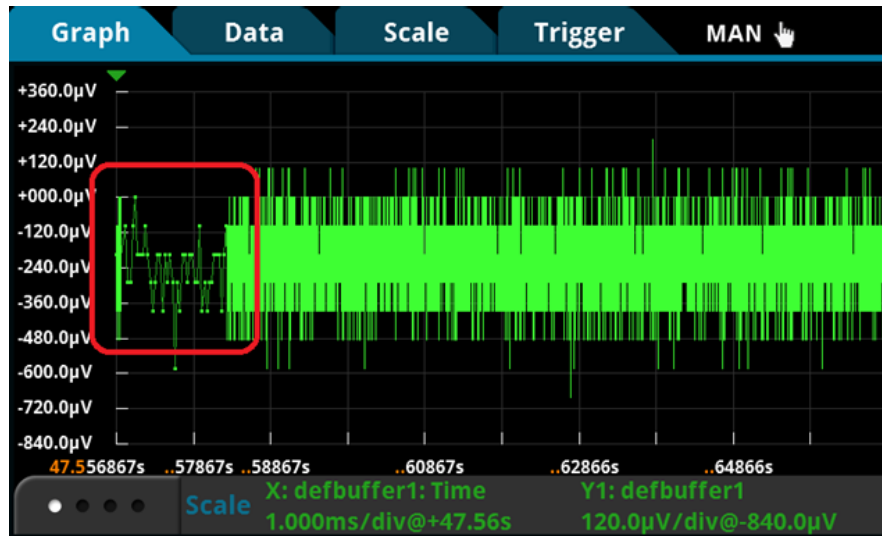
PR54974, UI graph occasionally appears to be missing digitizer data
PR54934

When using the UI to view bursts of digitizer data on the graph, you may see areas that appear to have missing data. See the example in the image below. Even though data is being sampled consistently throughout the viewable range, it appears as though fewer points are available in the circled area.

This may only occur when more than 5,000 points are visible on the graph at once and sample rates exceed 50k.

**Workaround:**

Pan or scale the graph by touching it to force a refresh. All data will appear. The measurements were taken and are in the buffer.
