Keithley Instruments
28775 Aurora Road
Cleveland, Ohio 44139
1-800-833-9200
tek.com/keithley

Model DMM7510 7½ Digit Graphical Multimeter
DMM7510-NFP
DMM7510-NFP-RACK
DMM7510-RACK

VERSION 1.7.5 RELEASE

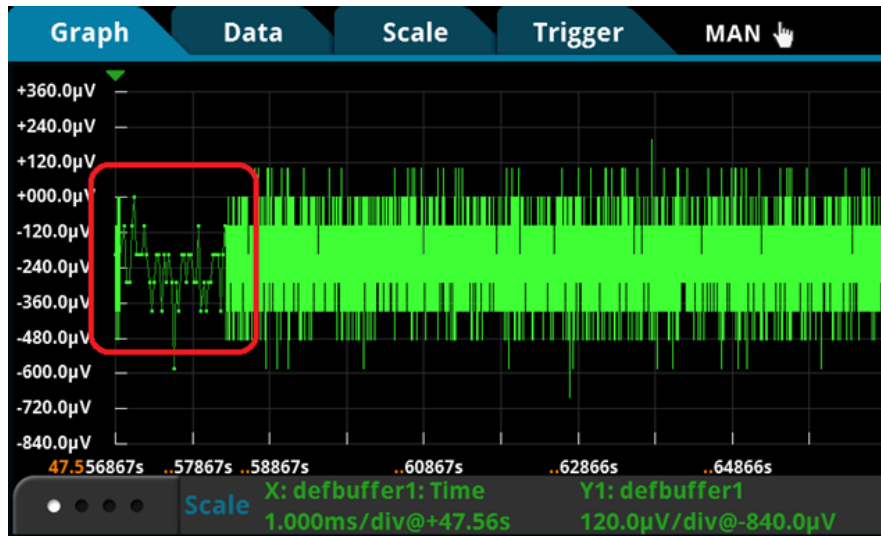
PR54974, UI graph occasionally appears to be missing digitizer data
PR54934

When using the UI to view bursts of digitizer data on the graph, you may see areas that appear to have missing data. See the example in the image below. Even though data is being sampled consistently throughout the viewable range, it appears as though fewer points are available in the circled area.

This may only occur when more than 5,000 points are visible on the graph at once and sample rates exceed 50k.

**Workaround:**

Pan or scale the graph by touching it to force a refresh. All data will appear. The measurements were taken and are in the buffer.
