Model DMM7512 7½ Digit Graphical Multimeter

VERSION 1.7.0 RELEASE

VERSION V1.6.7D RELEASE

VERSION V1.6.6F RELEASE

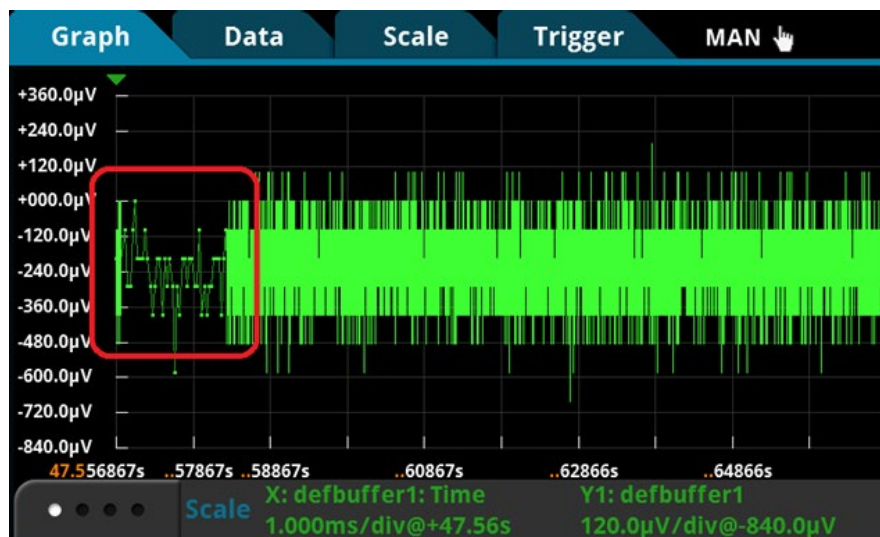
PR54974, UI graph occasionally appears to be missing digitizer data
PR54934

When using the UI to view bursts of digitizer data on the graph, you may see areas that appear to have missing data. See the example in the image below. Even though data is being sampled consistently throughout the viewable range, it appears as though fewer points are available in the circled area.

This may only occur when more than 5,000 points are visible on the graph at once and sample rates exceed 50k.

Pan or scale the graph by touching it to force a refresh. All data will appear. The measurements were taken and are in the buffer.

If you touch the screen in “Continuous Measurement Triggering” mode, panning in the time dimension will lock your time position. This will freeze your view on older data. If you continue to take measurements, your data will correctly disappear when the buffer wraps and the older data you were looking at is overwritten (assuming your buffer is continuous). If you wish to avoid this, it may be helpful to put the instrument in Manual (“Trigger Key Triggering”) mode and manually trigger each acquisition using the TRIGGER key.
