Keithley Instruments
28775 Aurora Road
Cleveland, Ohio 44139
1-800-833-9200
tek.com/keithley

Model DMM7512 7½ Digit Graphical Multimeter

VERSION 1.7.10 RELEASE

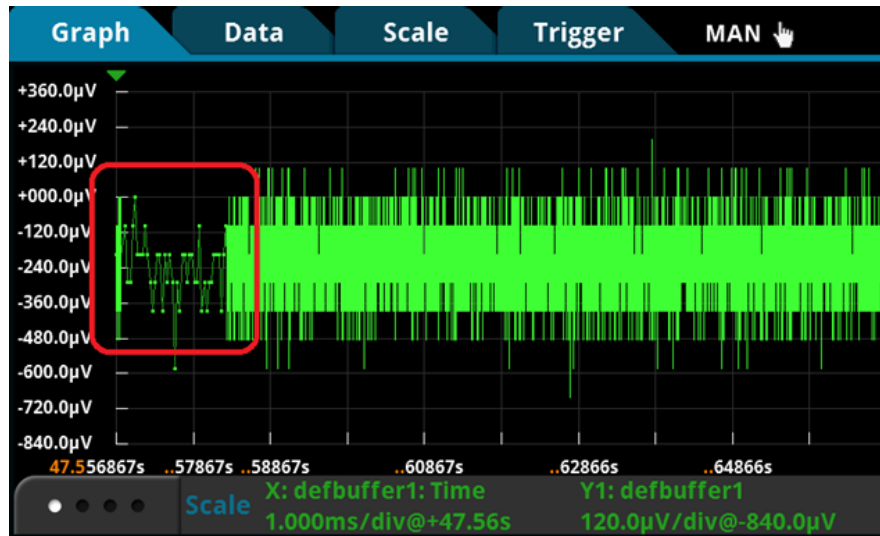
PR54974, UI graph occasionally appears to be missing digitizer data
PR54934

When using the UI to view bursts of digitizer data on the graph, you may see areas that appear to have missing data. See the example in the image below. Even though data is being sampled consistently throughout the viewable range, it appears as though fewer points are available in the circled area.

This may only occur when more than 5,000 points are visible on the graph at once and sample rates exceed 50k.

Pan or scale the graph by touching it to force a refresh. All data will appear. The measurements were taken and are in the buffer.
