Model DMM7512 7½ Digit Graphical Multimeter

## VERSION 1.7.12 RELEASE

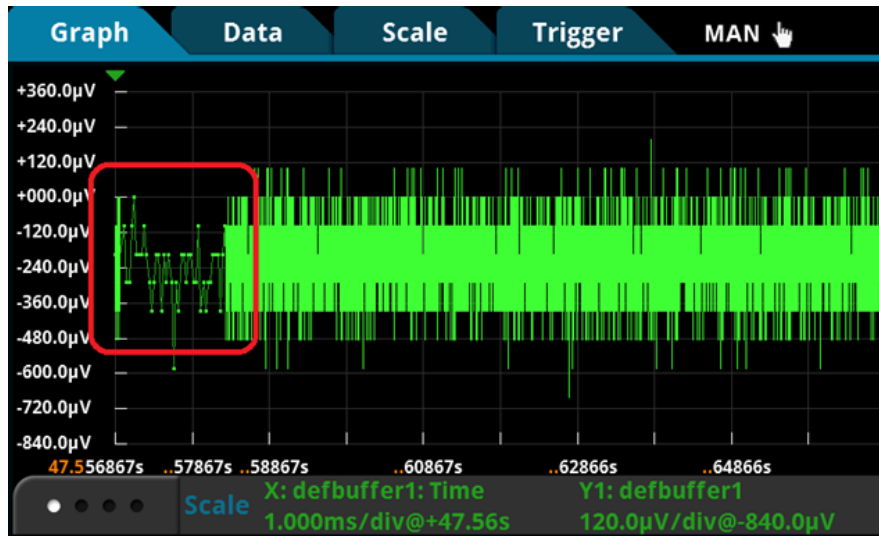
PR54974, UI graph occasionally appears to be missing digitizer data  
PR54934

When using the UI to view bursts of digitizer data on the graph, you may see areas that appear to have missing data. See the example in the image below. Even though data is being sampled consistently throughout the viewable range, it appears as though fewer points are available in the circled area.

This may only occur when more than 5,000 points are visible on the graph at once and sample rates exceed 50k.

Pan or scale the graph by touching it to force a refresh. All data will appear. The measurements were taken and are in the buffer.
