# DMM7512 7½ Digit Graphical Multimeter

## Version 1.7.16 Firmware Release Notes

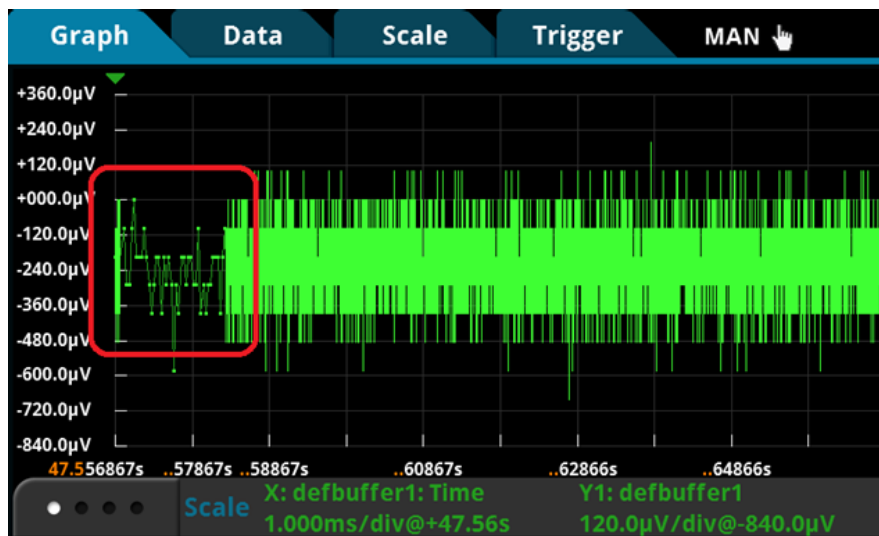
PR54974, UI graph occasionally appears to be missing digitizer data  
PR54934

When using the UI to view bursts of digitizer data on the graph, you may see areas that appear to have missing data. See the example in the image below. Even though data is being sampled consistently throughout the viewable range, it appears as though fewer points are available in the circled area.

This may only occur when more than 5,000 points are visible on the graph at once and sample rates exceed 50k.

Pan or scale the graph by touching it to force a refresh. All data will appear. The measurements were taken and are in the buffer.
