This firmware is used on the following Keithley Instruments product models:

Model DMM7512 7½ Digit Graphical Multimeter

## VERSION 1.7.18 RELEASE

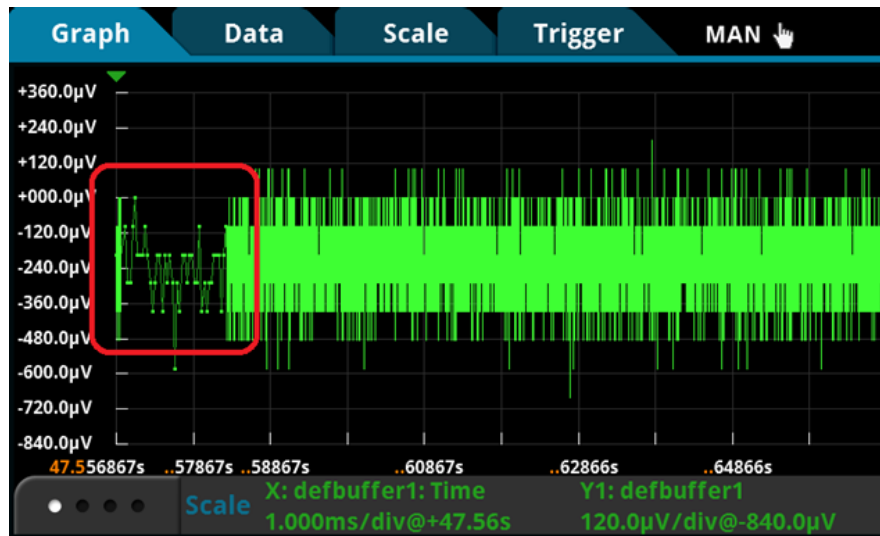
PR54974, UI graph occasionally appears to be missing digitizer data  
PR54934

When using the UI to view bursts of digitizer data on the graph, you may see areas that appear to have missing data. See the example in the image below. Even though data is being sampled consistently throughout the viewable range, it appears as though fewer points are available in the circled area.

This may only occur when more than 5,000 points are visible on the graph at once and sample rates exceed 50k.

Pan or scale the graph by touching it to force a refresh. All data will appear. The measurements were taken and are in the buffer.
