DMM7512 7½ Digit Graphical Multimeter

Version 1.7.2 Firmware Release Notes

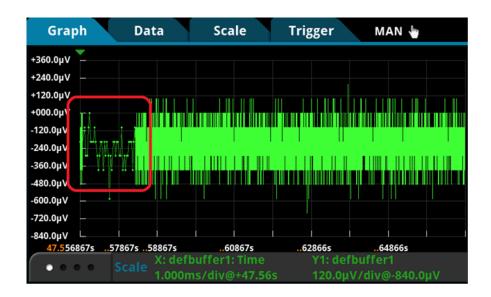
PR54974, UI graph occasionally appears to be missing digitizer data

Symptom:

When using the UI to view bursts of digitizer data on the graph, you may see areas that appear to have missing data. See the example in the image below. Even though data is being sampled consistently throughout the viewable range, it appears as though fewer points are available in the circled area.

This may only occur when more than 5,000 points are visible on the graph at once and sample rates exceed 50k.

Workaround:

Pan or scale the graph by touching it to force a refresh. All data will appear. The measurements were taken and are in the buffer.
