Model DMM7512 71/2 Digit Graphical Multimeter

Version 1.6.7d Firmware Release Notes

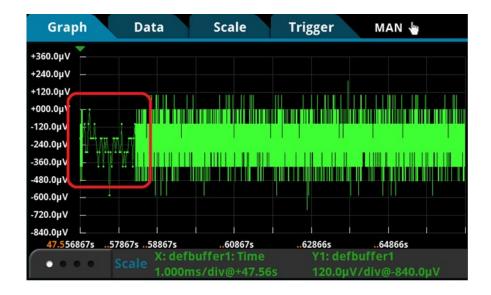
PR54974, UI graph occasionally appears to be missing digitizer data

When using the UI to view bursts of digitizer data on the graph, you may see areas that appear to have missing data. See the example in the image below. Even though data is being sampled consistently throughout the viewable range, it appears as though fewer points are available in the circled area.

This may only occur when more than 5,000 points are visible on the graph at once and sample rates exceed 50k.

Pan or scale the graph by touching it to force a refresh. All data will appear. The measurements were taken and are in the buffer.
