Keithley Instruments
28775 Aurora Road
Cleveland, Ohio 44139
1-800-833-9200
tek.com/keithley

Model DMM7510 7½ Digit Graphical Multimeter
DMM7510-NFP
DMM7510-NFP-RACK
DMM7510-RACK

VERSION 1.7.5 RELEASE

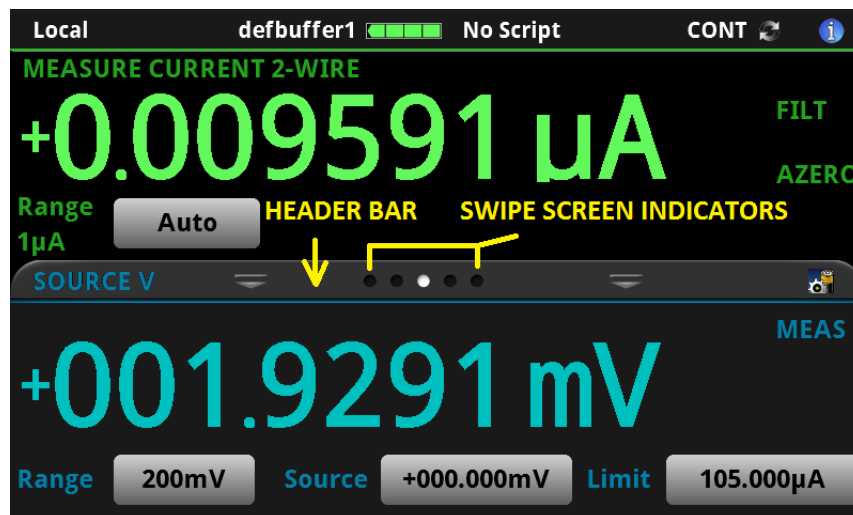
- e. Swipe Down on the Home screen will display larger readings.
4. Tabs and Buttons: Throughout the user interface multiple data display options have been made available through tabs (header bars) with swipe screen indicators to show how many options are available and which display tab is active.
