Why do I get 'Number of Pulses not Supported' when using Burst Mode?

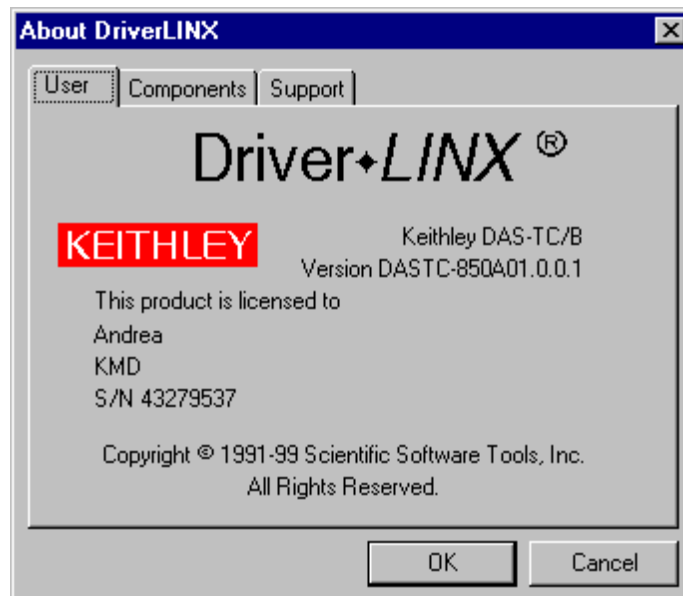
When this driver update has been applied, the 'About DriverLINX' applet (Start Menu > Programs > DriverLINX > About DriverLINX) will report the version as shown below:
