Debugging a Mixed Signal Design with a Tektronix Mixed Signal Oscilloscope

Application Note

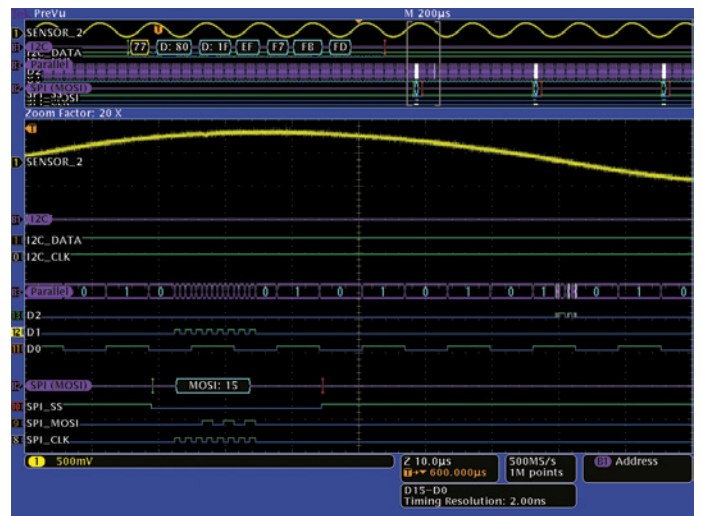
Figure 4. Wave Inspector[®] is used to zoom in and show packet detail.

0x77. Address 0x77 is the address of the FPGA, but the subroutine was supposed to write data to address 0x76 instead, which is the address of the LCD controller. Figure 4 shows the same acquisition while using Wave Inspector[®] Navigation and Search to zoom in on the details of the SPI and parallel buses. The SPI data is decoded on screen as a write from the master (FPGA) to the slave (MUX) with a data value of 0x15. This SPI command instructed the input MUX to change the input it was using for the signal path. This unexpected change in the input signal caused the FPGA to send an error code to the status LEDs on the parallel bus. The activity on signal D2 indicating the error code and the decoding of the parallel bus can be observed in Figure 4 as well. The embedded design engineer was quickly able to determine that a software bug had caused the malfunction in the system because the MSO/MDO Series oscilloscope was able to view and decode all the signals of interest simultaneously. The software programmer had mistakenly written I²C data from the microcontroller to the FPGA when the packet was intended for the LCD controller.

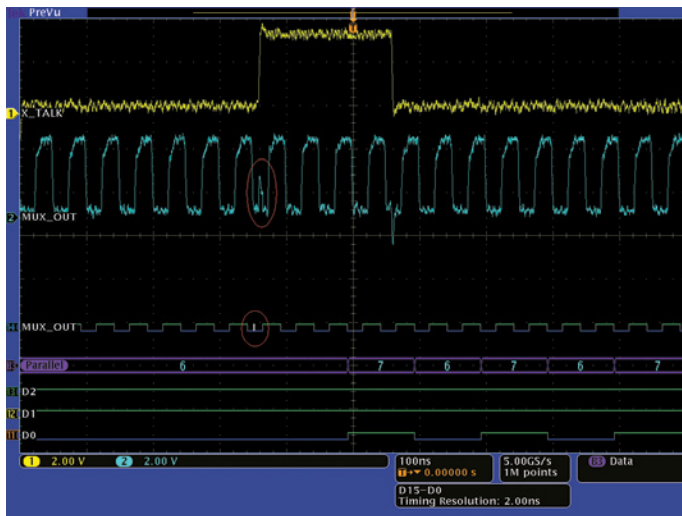
Figure 8. CH1 shows the source of crosstalk into the MUX_OUT signal.

he monitored in Figure 5 were identified as the source of crosstalk. While examining the circuit board layout in more detail, the engineer found a via located next to the MUX_OUT trace on the printed circuit board (PCB). The engineer probed the via on the PCB with CH1, and waited for another trigger from the parallel bus. The resulting screenshot is shown in Figure 8. Figure 8 shows that a low to high transition for the signal captured on CH1 directly correlates in time with a positive glitch on the MUX_OUT signal. Correspondingly, the high to low transition directly relates to a negative glitch on the MUX_OUT signal.
