Keithley Instruments
28775 Aurora Road
Cleveland, Ohio 44139
1-800-935-5595
<http://www.tek.com/keithley>

Software Release Notes & Installation Instructions

The 4200A-SCS Clarius+ software application suite is a release of the software for the 4200A-SCS. Clarius+ software requires **Microsoft® Windows® 10** to be installed on your 4200A-SCS Parameter Analyzer.

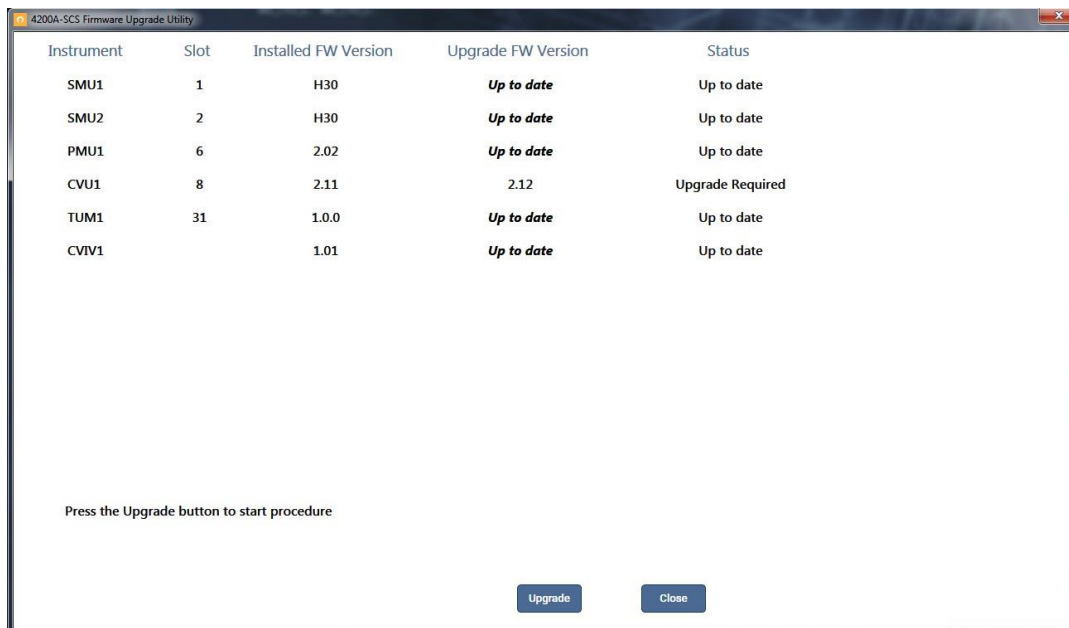
1. Exit all Clarius+ software programs and any other Windows® programs.
2. From the Windows® taskbar, select **Start**.
3. In the Keithley Instruments folder, select the **Firmware Upgrade** tool.
4. If your instrument needs to be upgraded, the Upgrade button becomes visible and there is an indication in Status that an Upgrade is required for a particular instrument as shown below.
5. Select **Upgrade**.
