Software Release Notes & Installation Instructions

These release notes contain important information about version 1.5.2 of the AFG31000 software.

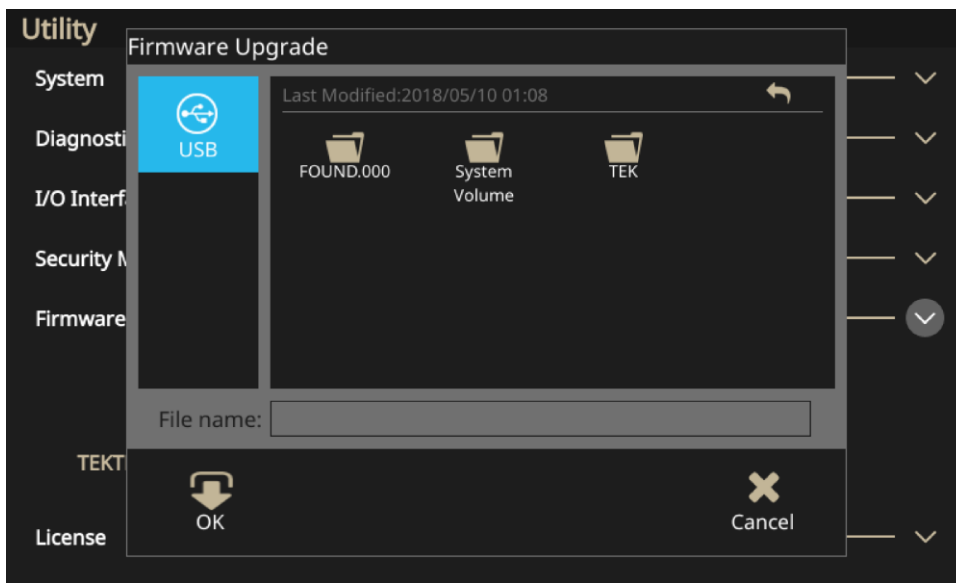
1. Visit tek.com and search for the Series 31000 firmware.
2. Download the compressed .zip file to your computer.
3. Unzip the downloaded file and copy the .ftb file to the USB flash drive root directory.
4. Insert the USB in the AFG31000 Series instrument front panel.
5. Press the **Utility** button.
6. Select **Firmware > Update**.
7. Select the USB icon.

8. Select the file that you are using to update your instrument.
9. Select **Recall** (you will see a message asking to confirm this update).
10. Verify that the instrument powered off and powered on to install the update.
11. Remove the USB drive.
