## Software Release Notes and Installation Instructions

These release notes contain important information about version 1.6.4 of the AFG31000 software.

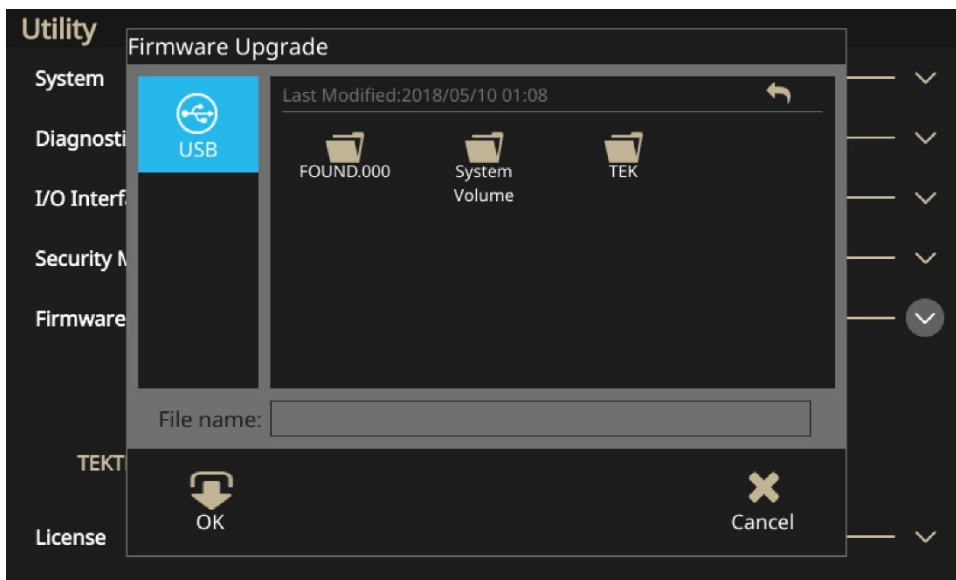
1. Visit [tek.com](http://tek.com) and search for the Series 31000 firmware.
2. Download the compressed .zip file to your computer.
3. Unzip the downloaded file and copy the .tfb file to the USB flash drive root directory.
4. Insert the USB in the AFG31000 Series instrument front panel.
5. Press the **Utility** button.
6. Select **Firmware > Update**.
7. Select the USB icon.
