Tektronix, Inc.
13725 SW Karl Braun Drive
P.O. Box 500
Beaverton, OR 97077
USA

Software Release Notes and Installation Instructions

These release notes contain important information about version 1.6.5 of the AFG31000 software.

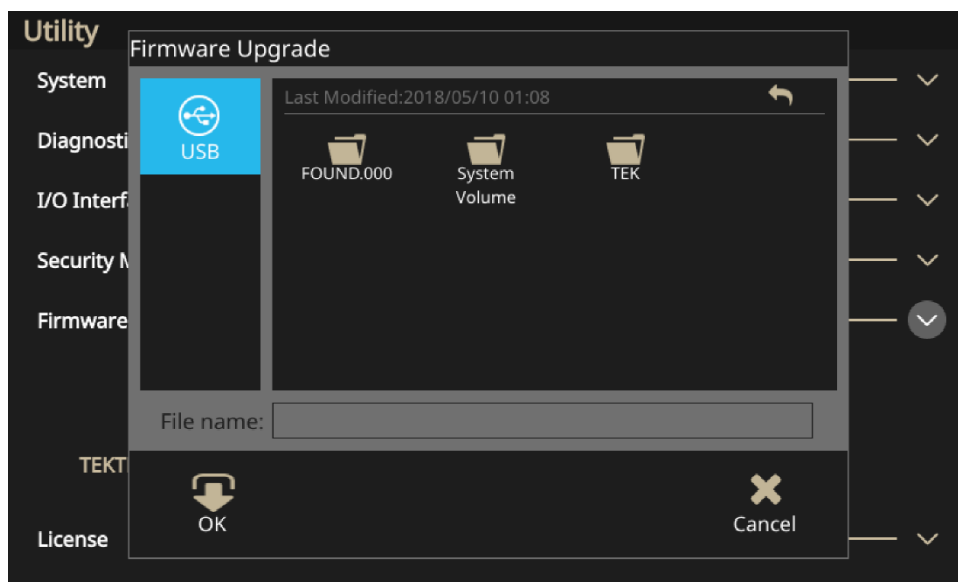
1. Visit tek.com and search for the Series 31000 firmware.
2. Download the compressed .zip file to your computer.
3. Unzip the downloaded file and copy the .tfb file to the USB flash drive root directory.
4. Insert the USB in the AFG31000 Series instrument front panel.
5. Press the **Utility** button.
6. Select **Firmware > Update**.
7. Select the USB icon.

8. Select the file that you are using to update your instrument.
9. Select **OK**. You will see a message asking to confirm this update.
10. Verify that the instrument powered off and powered on to install the update.
11. Remove the USB drive.
