Model 2450 Interactive SourceMeter® Instrument, 2450-NFP, 2450-RACK, 2450-NFP-RACK

VERSION 1.7.0 RELEASE

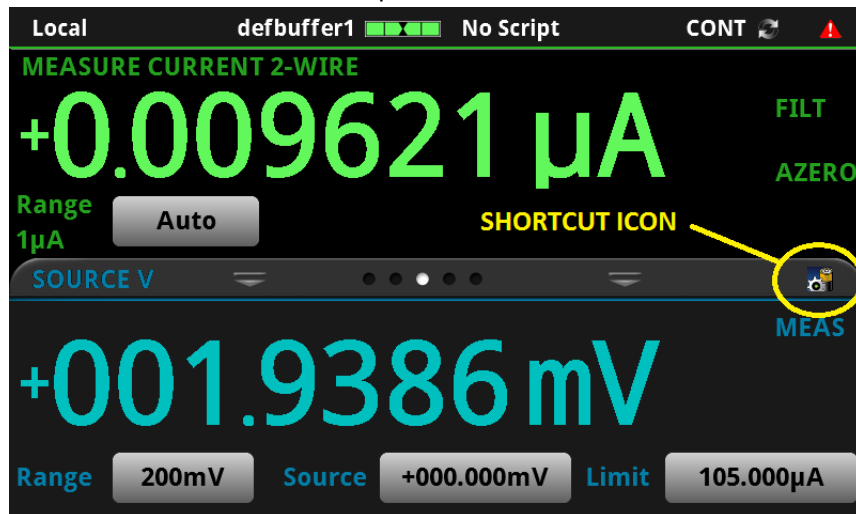
Add a direct shortcut from the HOME view measurement line to the measurement settings menu.

A shortcut icon has been added to the swipe bar on the HOME source/measurement tab.
