Keithley Instruments
28775 Aurora Road
Cleveland, Ohio 44139
1-800-833-9200
tek.com/keithley

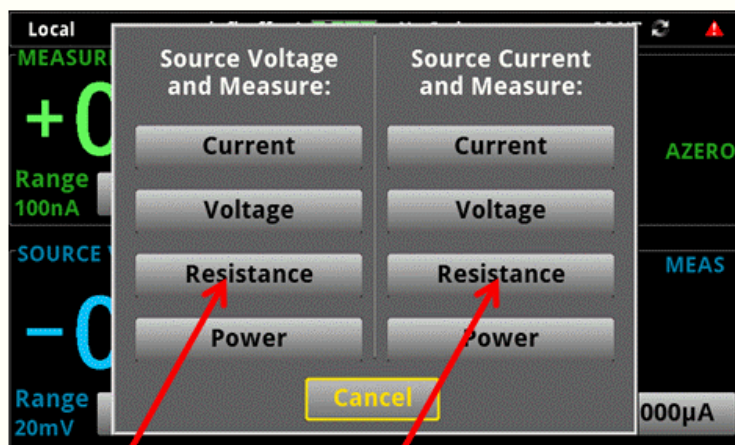
h. Front panel user interface setting of Manual vs. Auto Ohms measurements

<see the following figure for details>

SVMI (Ω)

SIMV (Ω)

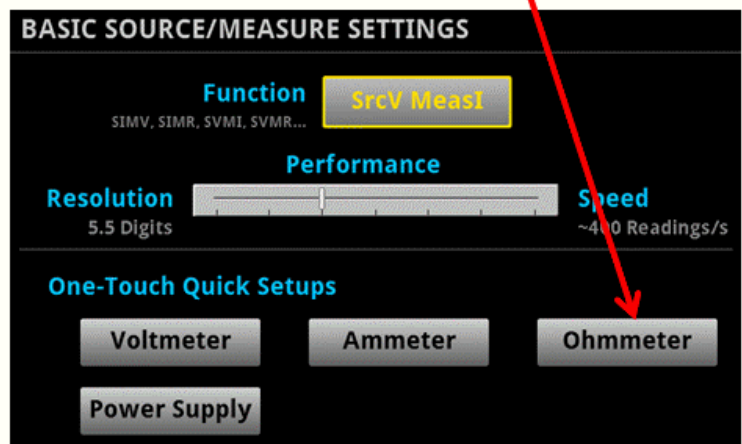
Exhibits "Auto" Ohms behavior

SVMR
