Keithley Instruments
28775 Aurora Road
Cleveland, Ohio 44139
1-800-833-9200
tek.com/keithley

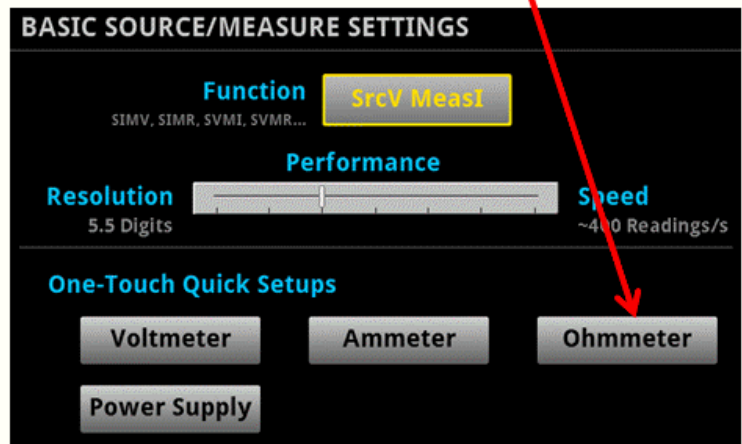
- g. New SCPI Command Usage:
 - i. "Manual Ohms" (see definition above)
 - SOURce:FUNC VOLTage
 - [SENSe[1]]:FUNC "CURRent"
 - [SENSe[1]]:CURRent:UNIT OHMOR
 - SOURce:FUNC CURRent
 - [SENSe[1]]:FUNC "VOLTage"
 - [SENSe[1]]:VOLTage:UNIT OHM
 - ii. "Auto Ohms" (see definition above)
 - [SENSe[1]]:FUNC "RESistance"
- h. Front panel user interface setting of Manual vs. Auto Ohms measurements
<see the following figure for details>

SVMI (Ω) SIMV (Ω)

Both exhibit "Manual" Ohms behavior (works just like Power by setting units to Ohms and going to SVMI or SIMV)

Exhibits "Auto" Ohms behavior

SVMR

- `smu.source.func = smu.FUNC_DC_CURRENT`
 - `smu.voltage.func = smu.FUNC_DC_VOLTAGE`
 - `smu.measure.unit = smu.UNIT_OHM`
 - ii. “Auto Ohms” → Measures resistance by sourcing current, measuring voltage, and calculating the resistance reading. In this case, the source current and source limit are automatically calculated and set.
 - `smu.measure.func = smu.FUNC_RESISTANCE`
