This firmware is used on the following Keithley Instruments product models:

Model 2450 Interactive SourceMeter® Instrument, 2450-NFP, 2450-RACK, 2450-NFP-RACK

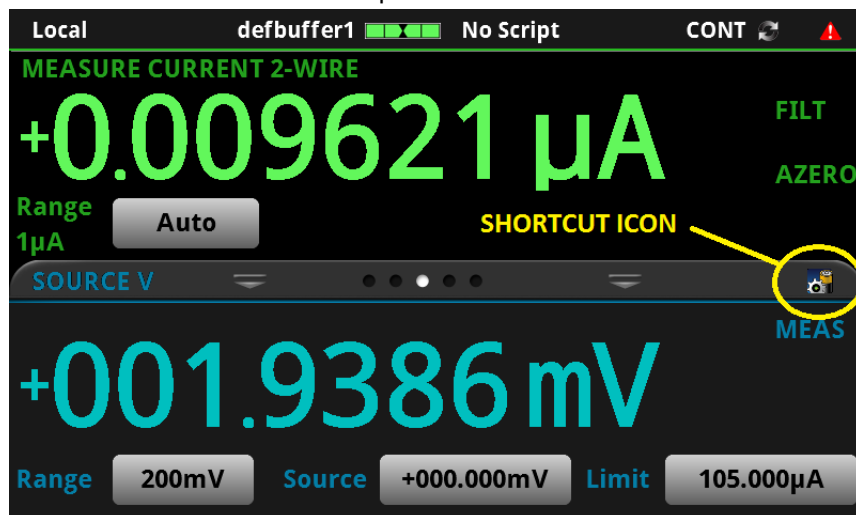
Add a direct shortcut from the HOME view measurement line to the measurement settings menu.

A shortcut icon has been added to the swipe bar on the HOME source/measurement tab.
