Keithley Instruments  
28775 Aurora Road  
Cleveland, Ohio 44139  
1-800-833-9200  
[tek.com/keithley](http://tek.com/keithley)

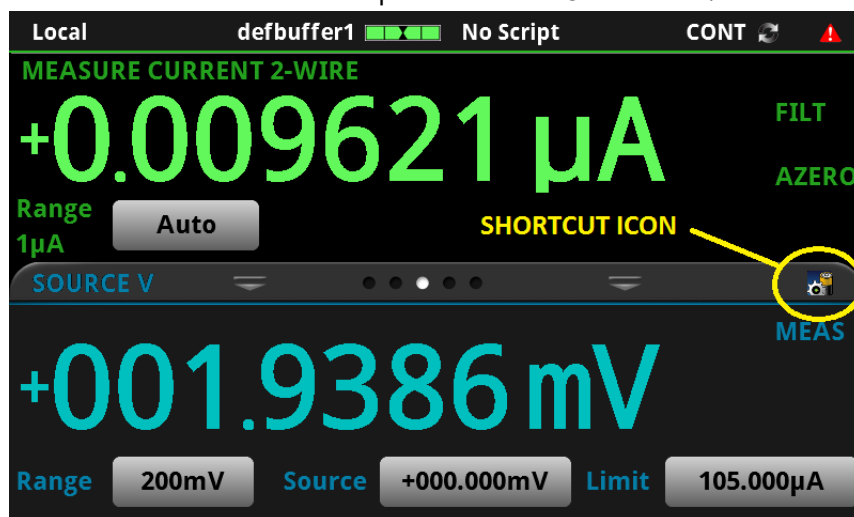
Add a direct shortcut from the HOME view measurement line to the measurement settings menu.

A shortcut icon has been added to the swipe bar on the HOME source/measurement tab.
