This firmware is used on the following Keithley Instruments product models:

Model 2450 Interactive SourceMeter Š Instrument, 2450-~~RP~~, 2450-RACK, 2450-NFP-RACK

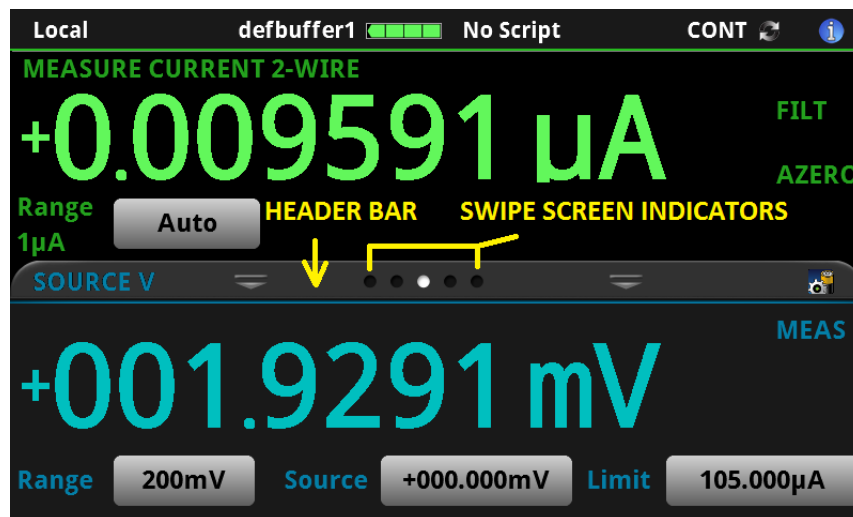
- e. Swipe Down on the Home screen will display larger readings.
4. Tabs and Buttons: Throughout the user interface multiple data display options have been made available through tabs (header bars) with swipe screen indicators to show how many options are available and which display tab is active.

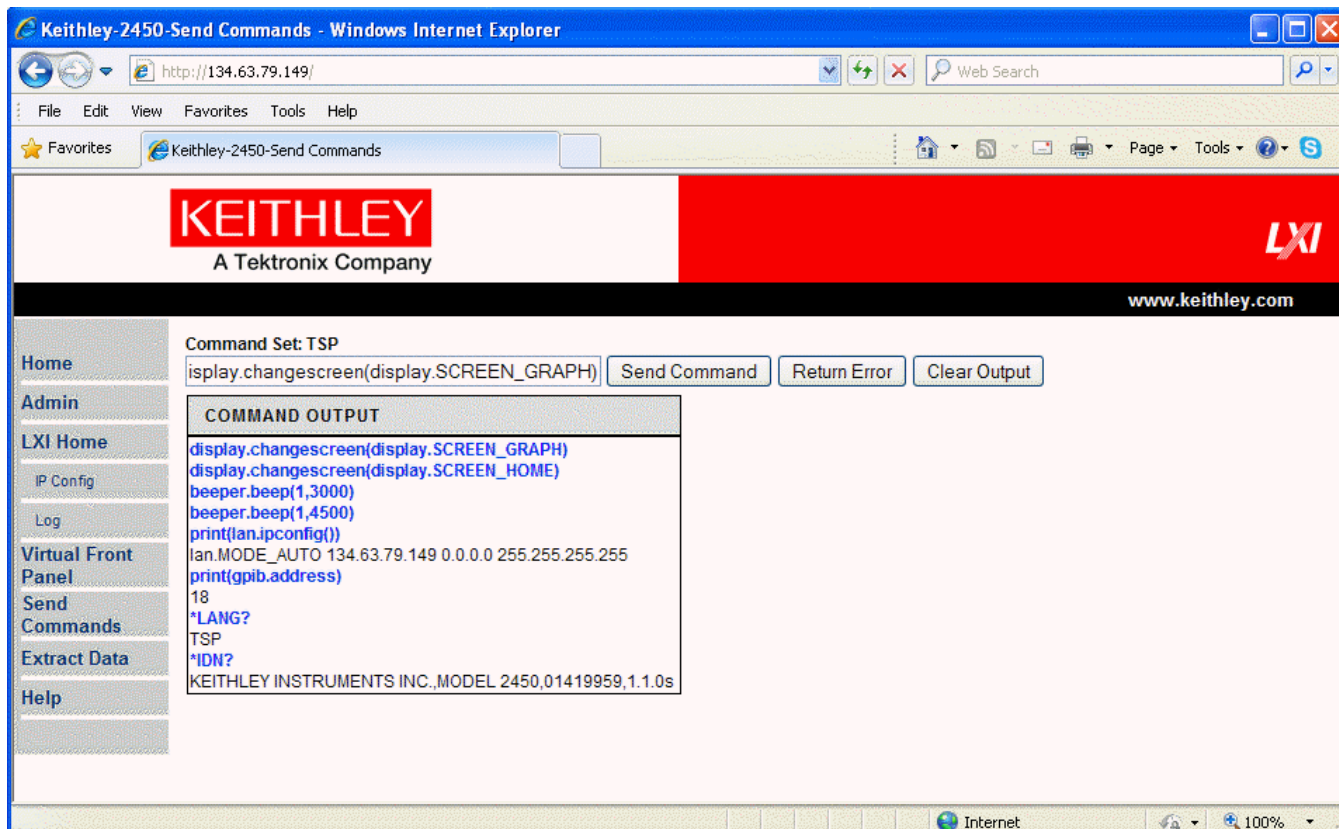
The 2450 built-in webpage has been enhanced to show a historical list of commands recently sent to the instrument. This new COMMAND OUTPUT window has been added to the Send Commands section of the webpage.

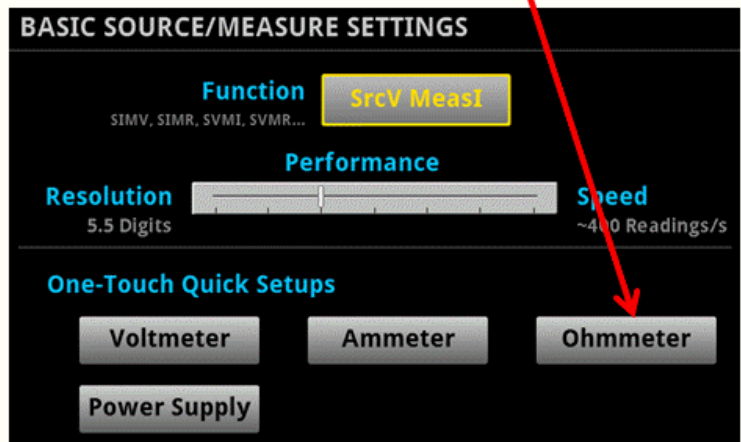
- g. New SCPI Command Usage:
 - i. "Manual Ohms" (see definition above)
 - SOURce:FUNC VOLTage
 - [SENSe[1]]:FUNC "CURREnt"
 - [SENSe[1]]:CURREnt:UNIT OHMOR
 - SOURce:FUNC CURREnt
 - [SENSe[1]]:FUNC "VOLTage"
 - [SENSe[1]]:VOLTage:UNIT OHM
 - ii. "Auto Ohms" (see definition above)
 - [SENSe[1]]:FUNC "RESistance"
- h. Front panel user interface setting of Manual vs. Auto Ohms measurements
<see the following figure for details>

SVMI (Ω) SIMV (Ω)

Both exhibit "Manual" Ohms behavior (works just like Power by setting units to Ohms and going to SVMI or SIMV)

Exhibits "Auto" Ohms behavior

SVMR

- `smu.source.func = smu.FUNC_DC_CURRENT`
 - `smu.voltage.func = smu.FUNC_DC_VOLTAGE`
 - `smu.measure.unit = smu.UNIT_OHM`
 - ii. “Auto Ohms” Measures resistance by sourcing current, measuring voltage, and calculating the resistance reading. In this case, the source current and source limit are automatically calculated and set.
 - `smu.measure.func = smu.FUNC_RESISTANCE`
