Model 2450 SourceMeter Instrument

Version 1.7.7 Firmware Release Notes

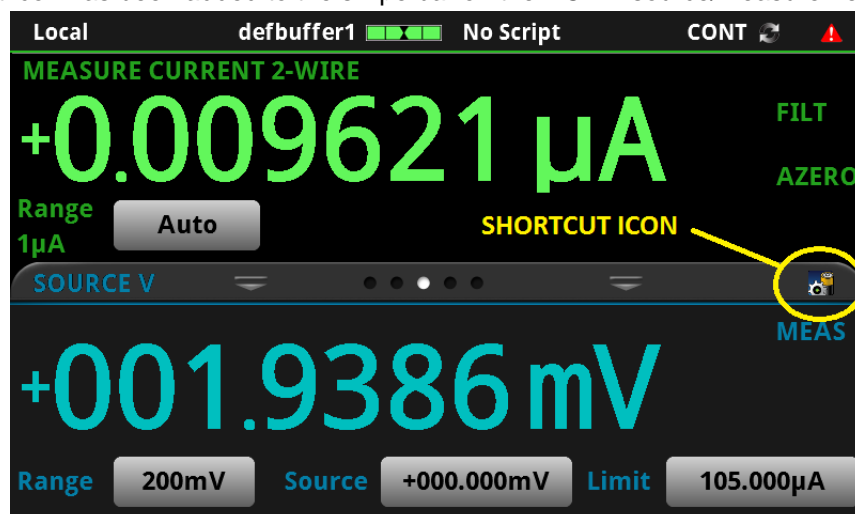
Add a direct shortcut from the HOME view measurement line to the measurement settings menu.

A shortcut icon has been added to the swipe bar on the HOME source/measurement tab.

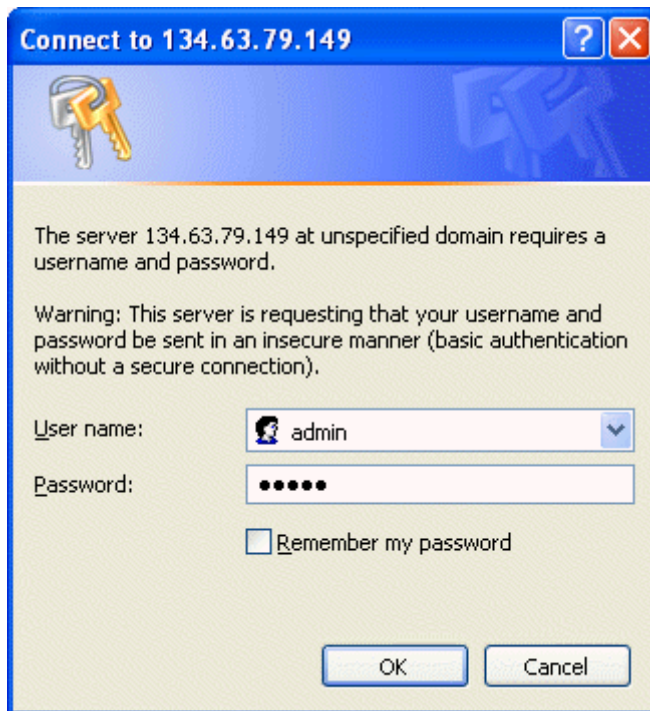
When asked for a Username and Password: enter the Username and Password for that particular 2450. The default Username is `admin` and the default Password is `admin`.

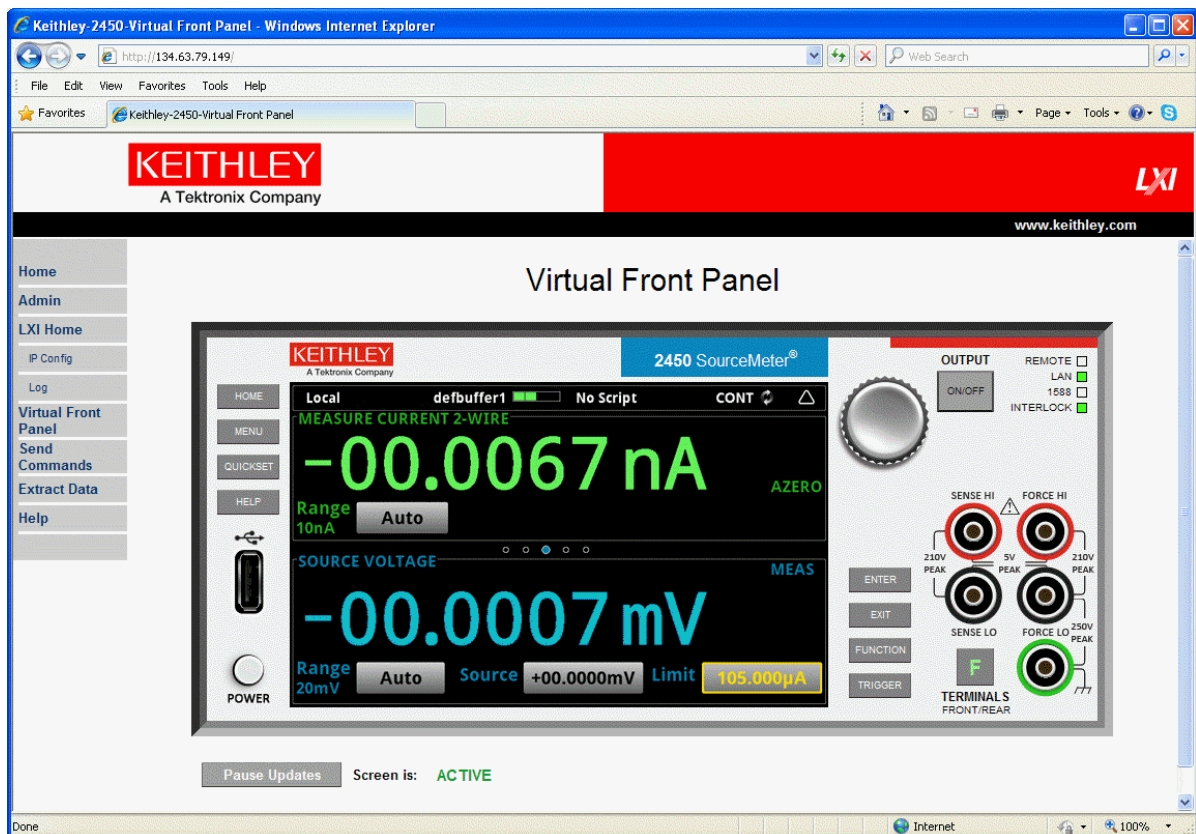
An example of the 2450 Virtual Front Panel is shown below. Users can use their mouse from a standard PC to control the instrument. Users can also use touch screens from most touch screen devices that can access the 2450 IP address.

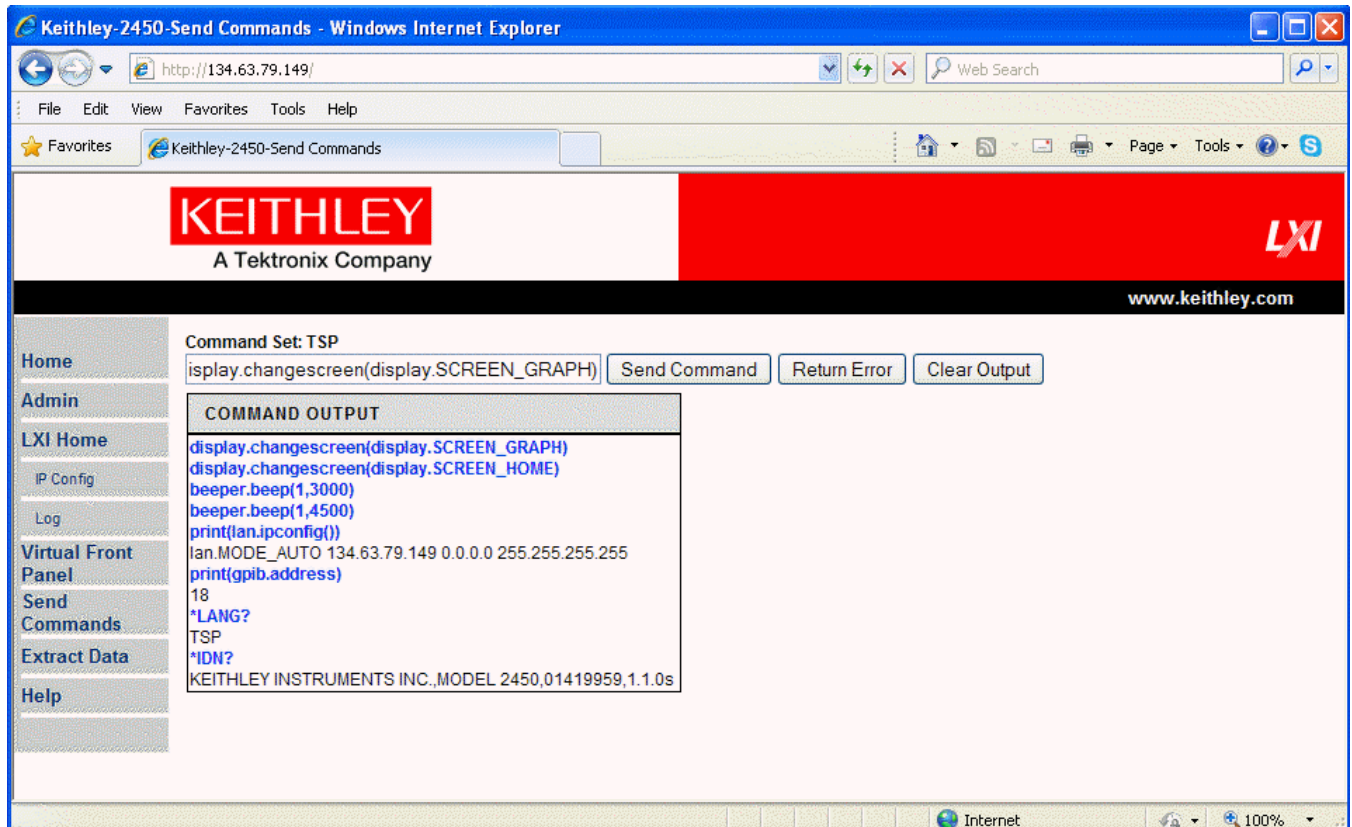
The 2450 built-in webpage has been enhanced to show a historical list of commands recently sent to the instrument. This new COMMAND OUTPUT window has been added to the Send Commands section of the webpage.

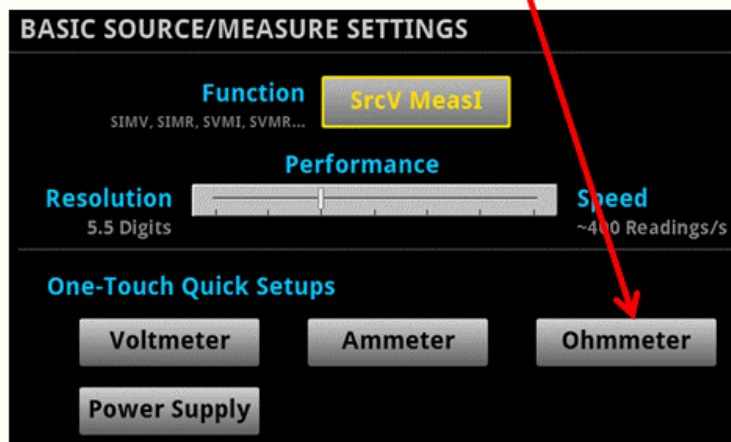
Exhibits "Auto" Ohms behavior

SVMR
