Keithley Instruments  
28775 Aurora Road  
Cleveland, Ohio 44139  
1-800-833-9200  
[tek.com/keithley](http://tek.com/keithley)

## GENERAL INFORMATION

Model 2450 Interactive SourceMeter® Instrument, 2450-NFP, 2450-RACK, 2450-NFP-RACK

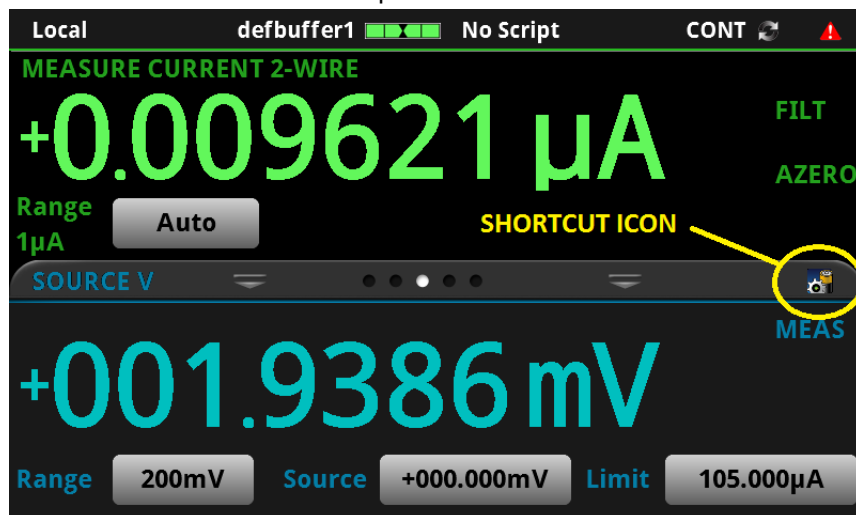
Add a direct shortcut from the HOME view measurement line to the measurement settings menu.

A shortcut icon has been added to the swipe bar on the HOME source/measurement tab.

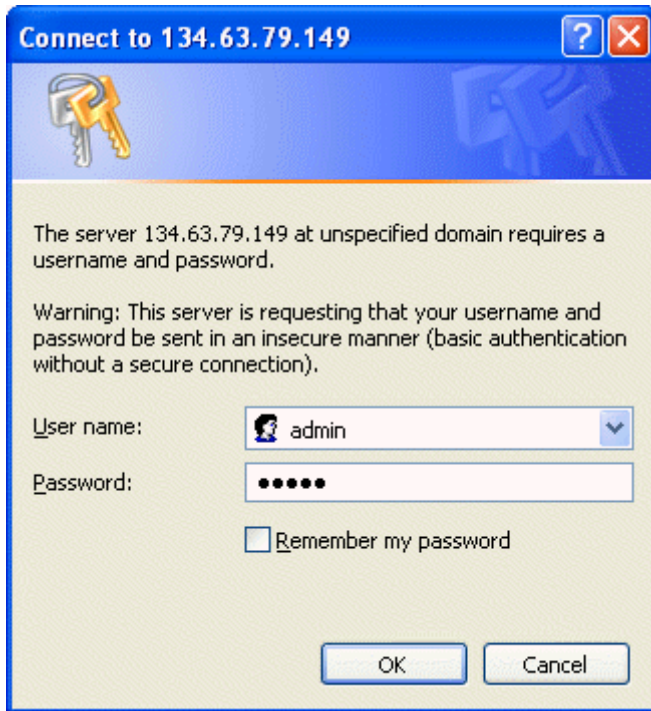
When asked for a Username and Password: enter the Username and Password for that particular 2450. The default Username is `admin` and the default Password is `admin`.

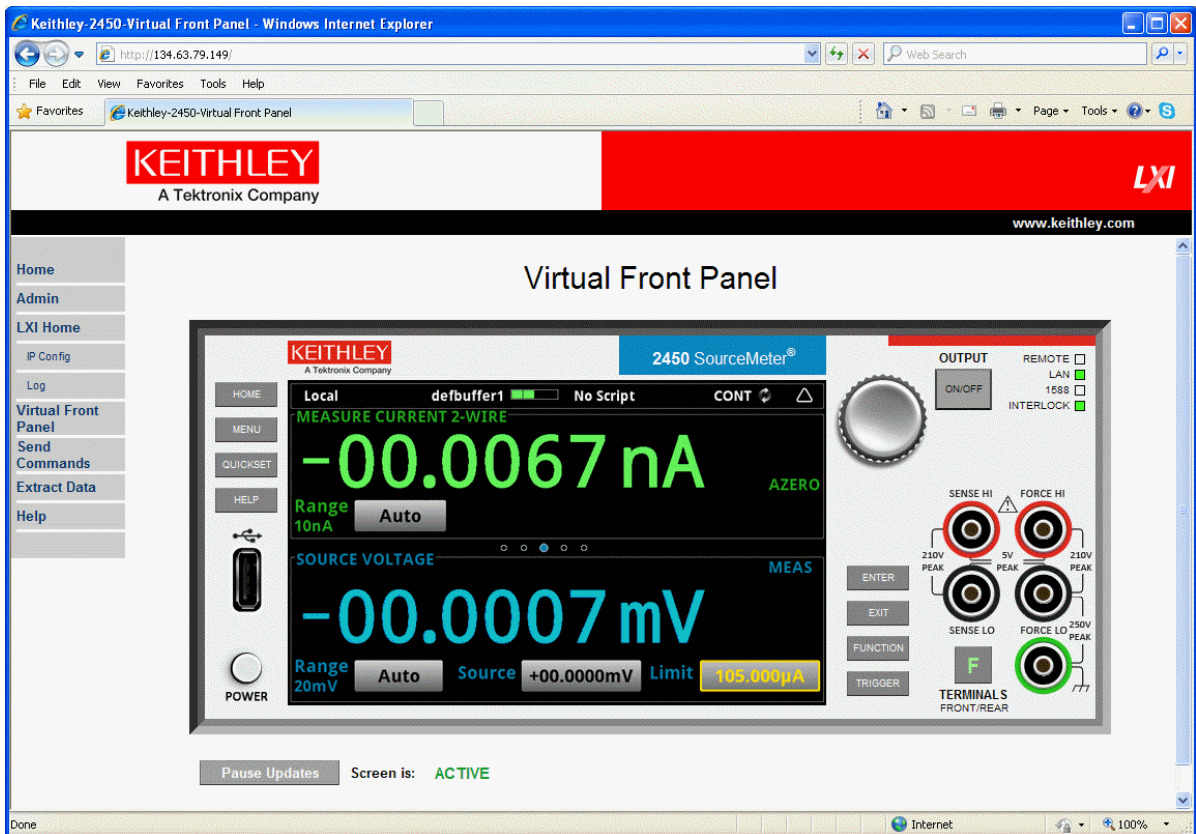
An example of the 2450 Virtual Front Panel is shown below. Users can use their mouse from a standard PC to control the instrument. Users can also use touch screens from most touch screen devices that can access the 2450 IP address.

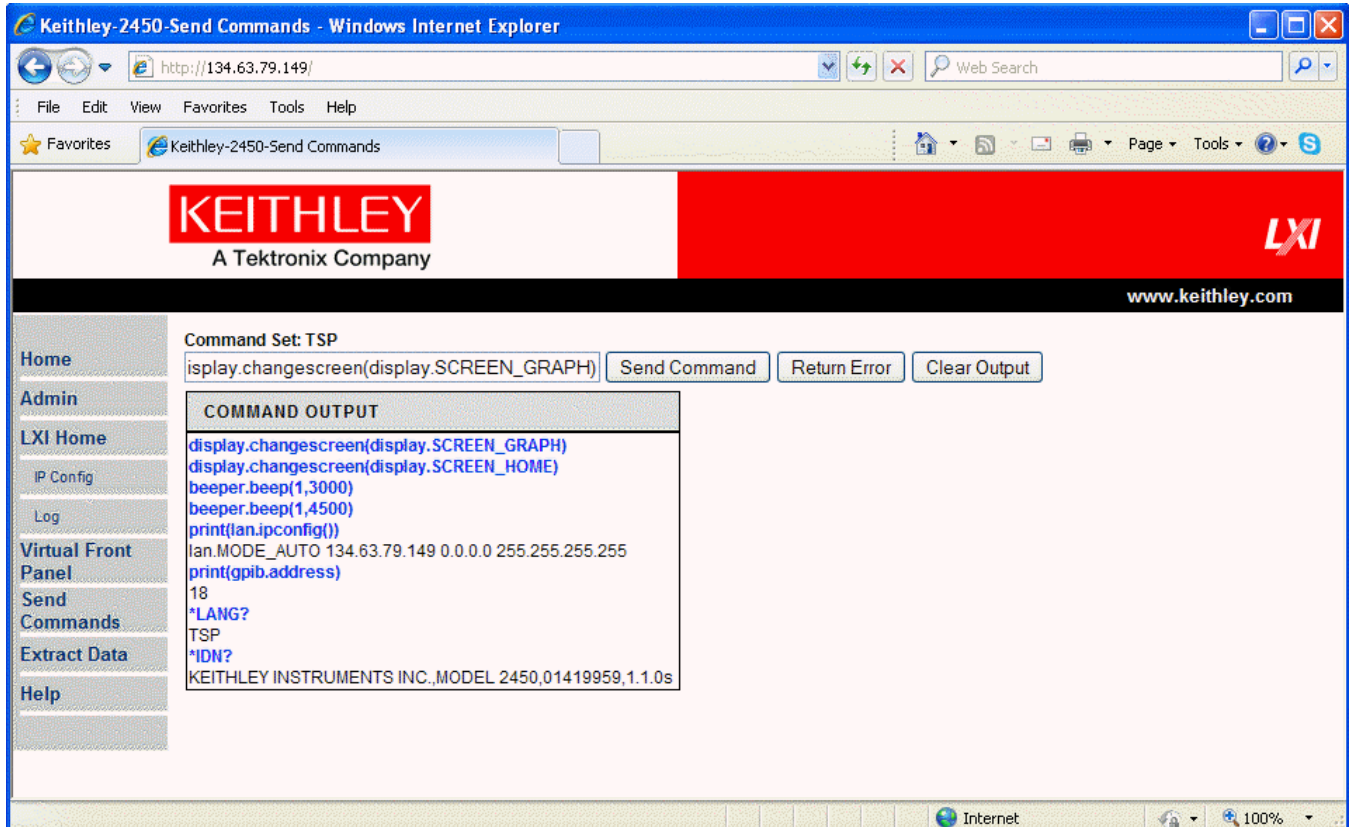
The 2450 built-in webpage has been enhanced to show a historical list of commands recently sent to the instrument. This new COMMAND OUTPUT window has been added to the Send Commands section of the webpage.

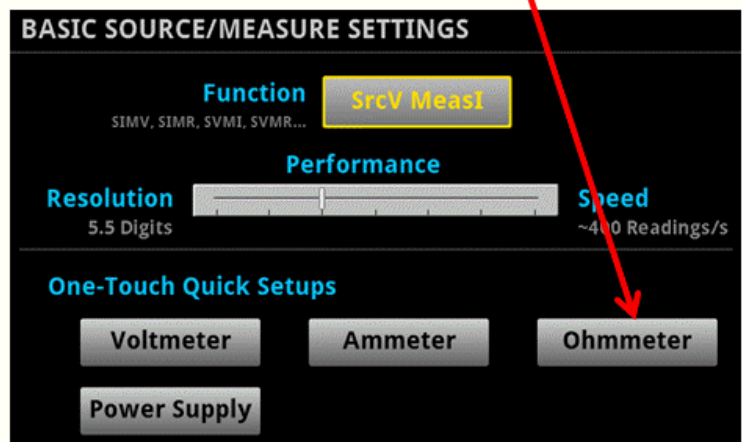
- g. New SCPI Command Usage:
  - i. "Manual Ohms" (see definition above)
    - SOURce:FUNC VOLTage
    - [SENSe[1]]:FUNC "CURRent"
    - [SENSe[1]]:CURRent:UNIT OHMOR
    - SOURce:FUNC CURRent
    - [SENSe[1]]:FUNC "VOLTage"
    - [SENSe[1]]:VOLTage:UNIT OHM
  - ii. "Auto Ohms" (see definition above)
    - [SENSe[1]]:FUNC "RESistance"
- h. Front panel user interface setting of Manual vs. Auto Ohms measurements  
<see the following figure for details>

SVMI ( $\Omega$ )

SIMV ( $\Omega$ )

Exhibits "Auto" Ohms behavior

SVMR

- `smu.source.func = smu.FUNC_DC_CURRENT`
    - `smu.voltage.func = smu.FUNC_DC_VOLTAGE`
    - `smu.measure.unit = smu.UNIT_OHM`
  - ii. “Auto Ohms” → Measures resistance by sourcing current, measuring voltage, and calculating the resistance reading. In this case, the source current and source limit are automatically calculated and set.
    - `smu.measure.func = smu.FUNC_RESISTANCE`
