Keithley Instruments, Inc.
 28775 Aurora Road
 Cleveland, Ohio 44139-1891
 1-888-KEITHLEY
 www.keithley.com

This firmware is intended for use on the following Keithley Instruments product models:

2450, 2450-NFP, 2450-RACK, 2450-NFP-RACK

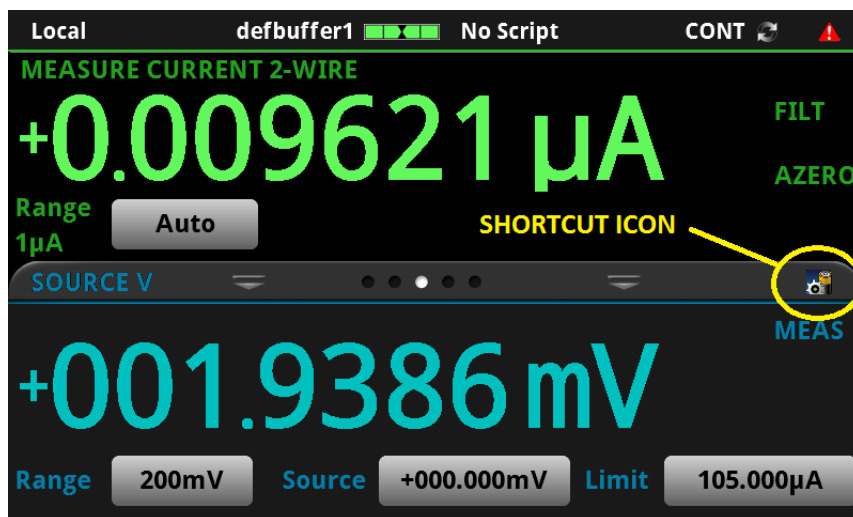
Add a direct shortcut from the HOME view measurement line to the measurement settings menu.

A shortcut icon has been added to the swipe bar on the HOME source/measurement tab.

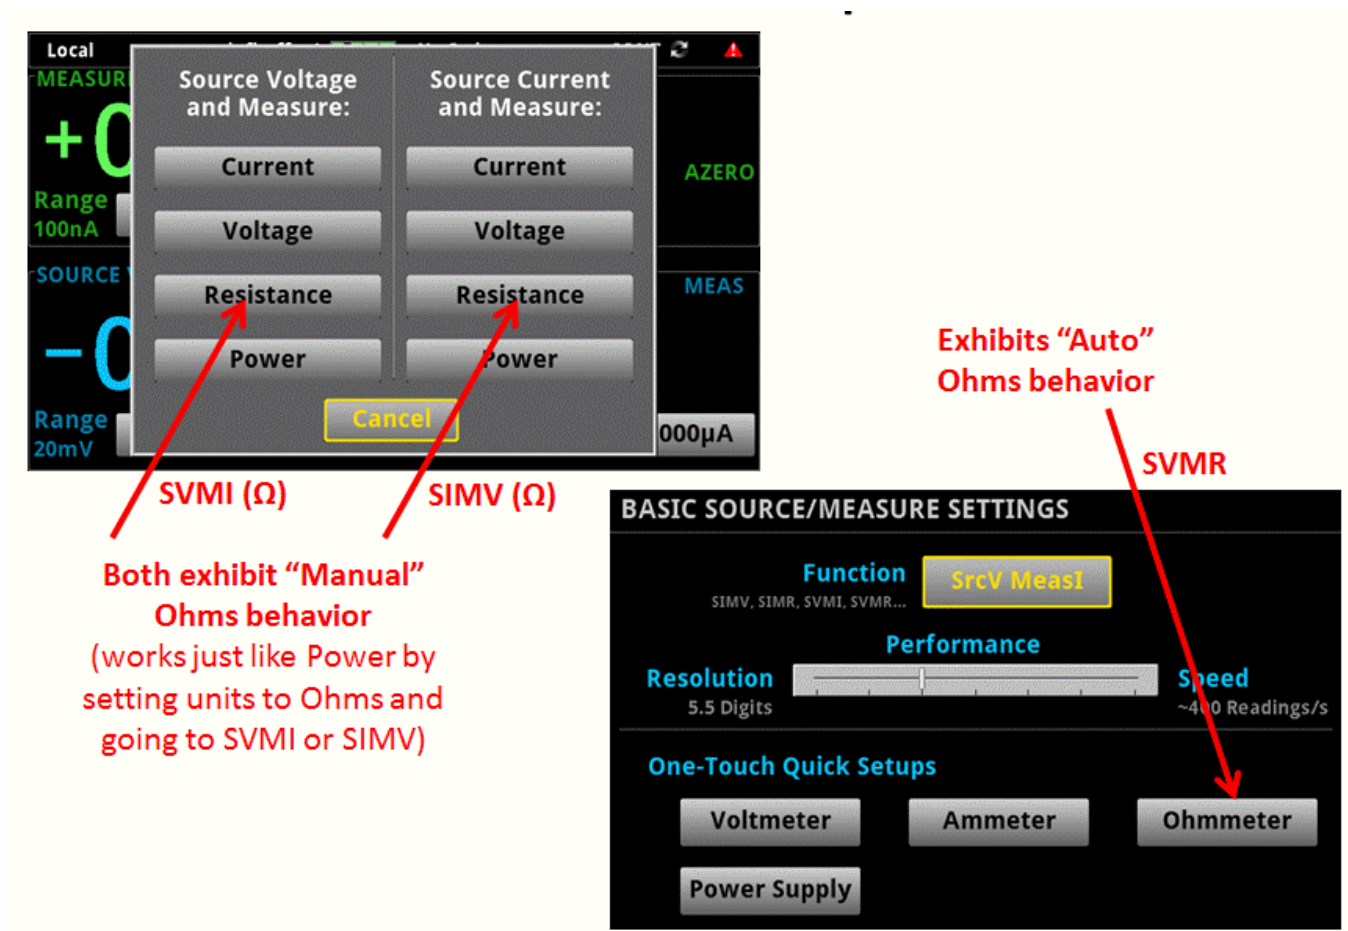
- `smu.measure.func = smu.FUNC_RESISTANCE`
- g. New SCPI Command Usage:
- i. "Manual Ohms" (see definition above)
 - `SOURCE:FUNC VOLTage`
 - `[SENSE[1]]:FUNC "CURRENT"`
 - `[SENSE[1]]:CURRENT:UNIT OHM`OR
 - `SOURCE:FUNC CURRENT`
 - `[SENSE[1]]:FUNC "VOLTage"`
 - `[SENSE[1]]:VOLTage:UNIT OHM`
 - ii. "Auto Ohms" (see definition above)
 - `[SENSE[1]]:FUNC "RESistance"`
- h. Front panel user interface setting of Manual vs. Auto Ohms measurements
- <see the following figure for details>

- `smu.source.func = smu.FUNC_DC_CURRENT`
 - `smu.voltage.func = smu.FUNC_DC_VOLTAGE`
 - `smu.measure.unit = smu.UNIT_OHM`
 - ii. “Auto Ohms” → Measures resistance by sourcing current, measuring voltage, and calculating the resistance reading. In this case, the source current and source limit are automatically calculated and set.
