Model 2450 System SourceMeter®

Version v1.6.4c Firmware Release Notes

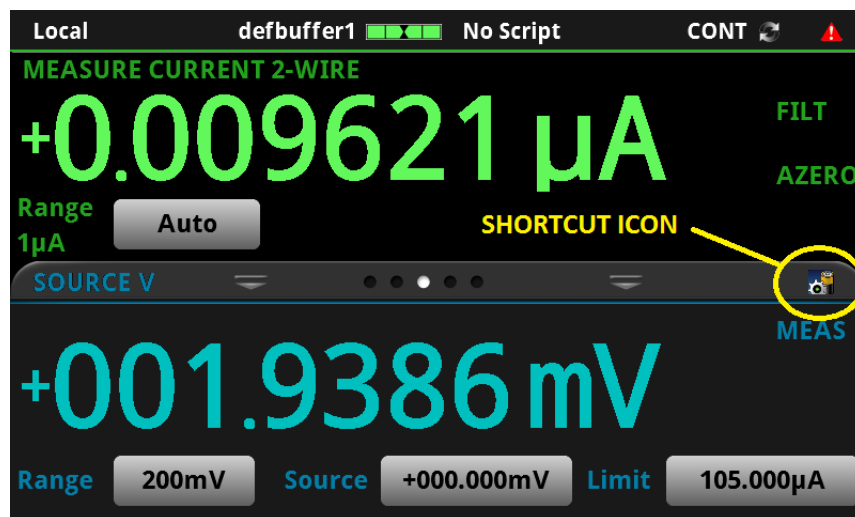
Add a direct shortcut from the HOME view measurement line to the measurement settings menu.

A shortcut icon has been added to the swipe bar on the HOME source/measurement tab.

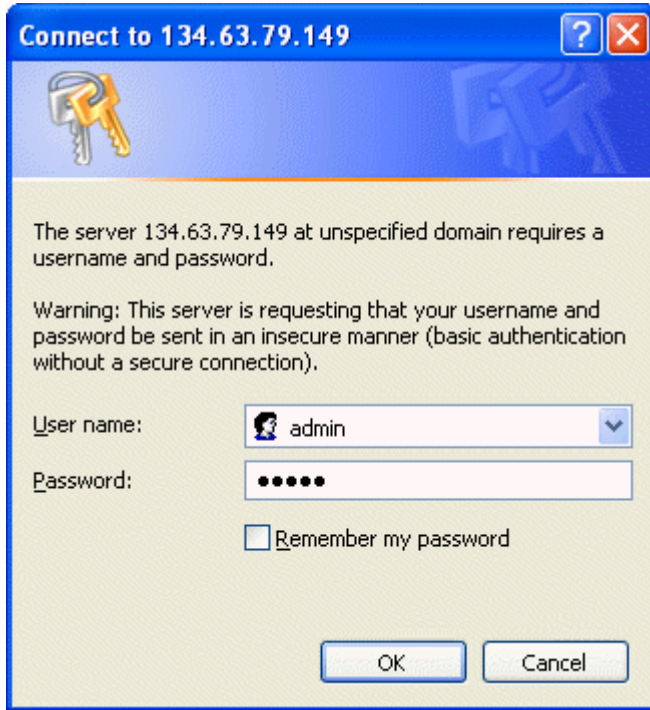
When asked for a Username and Password: enter the Username and Password for that particular 2450. The default Username is `admin` and the default Password is `admin`.

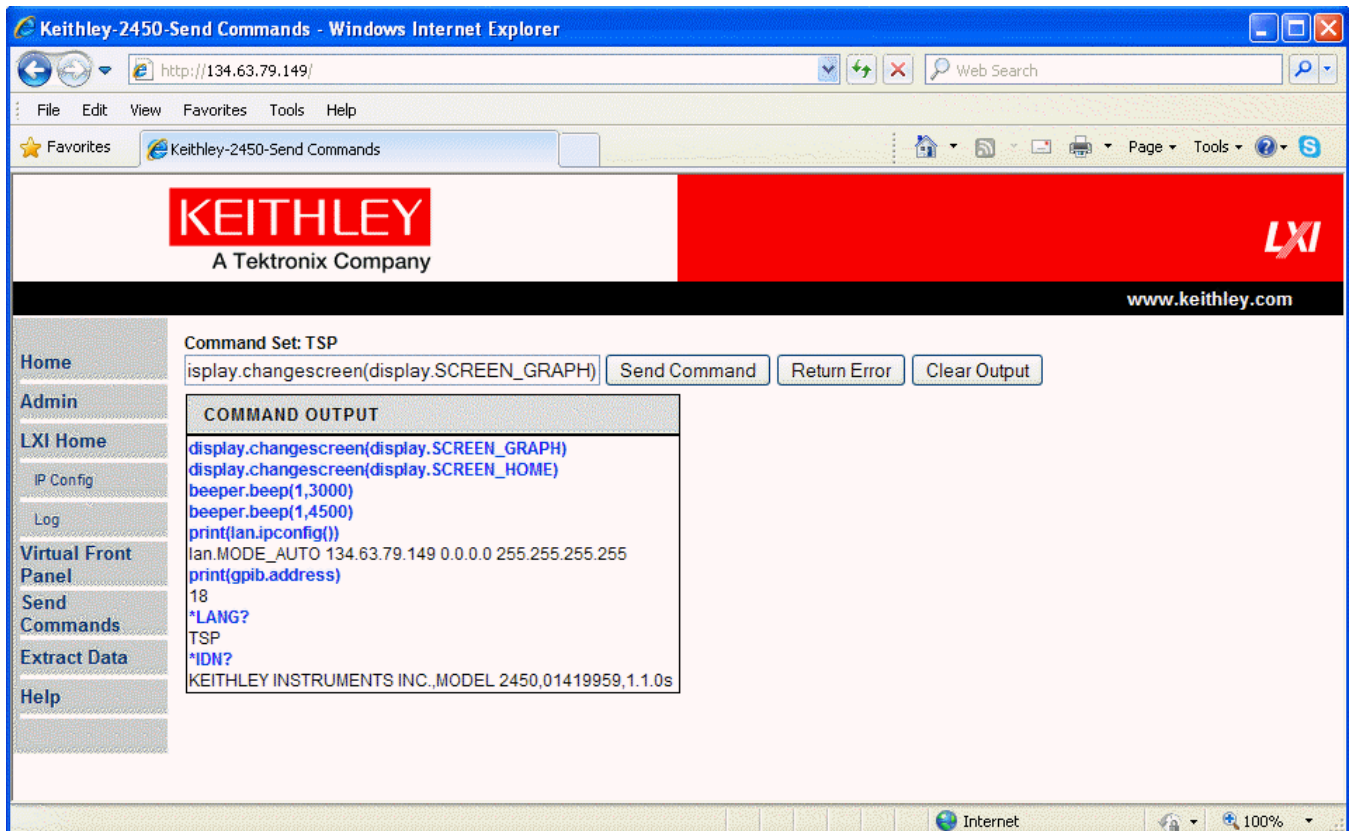
The 2450 built-in webpage has been enhanced to show a historical list of commands recently sent to the instrument. This new COMMAND OUTPUT window has been added to the Send Commands section of the webpage.

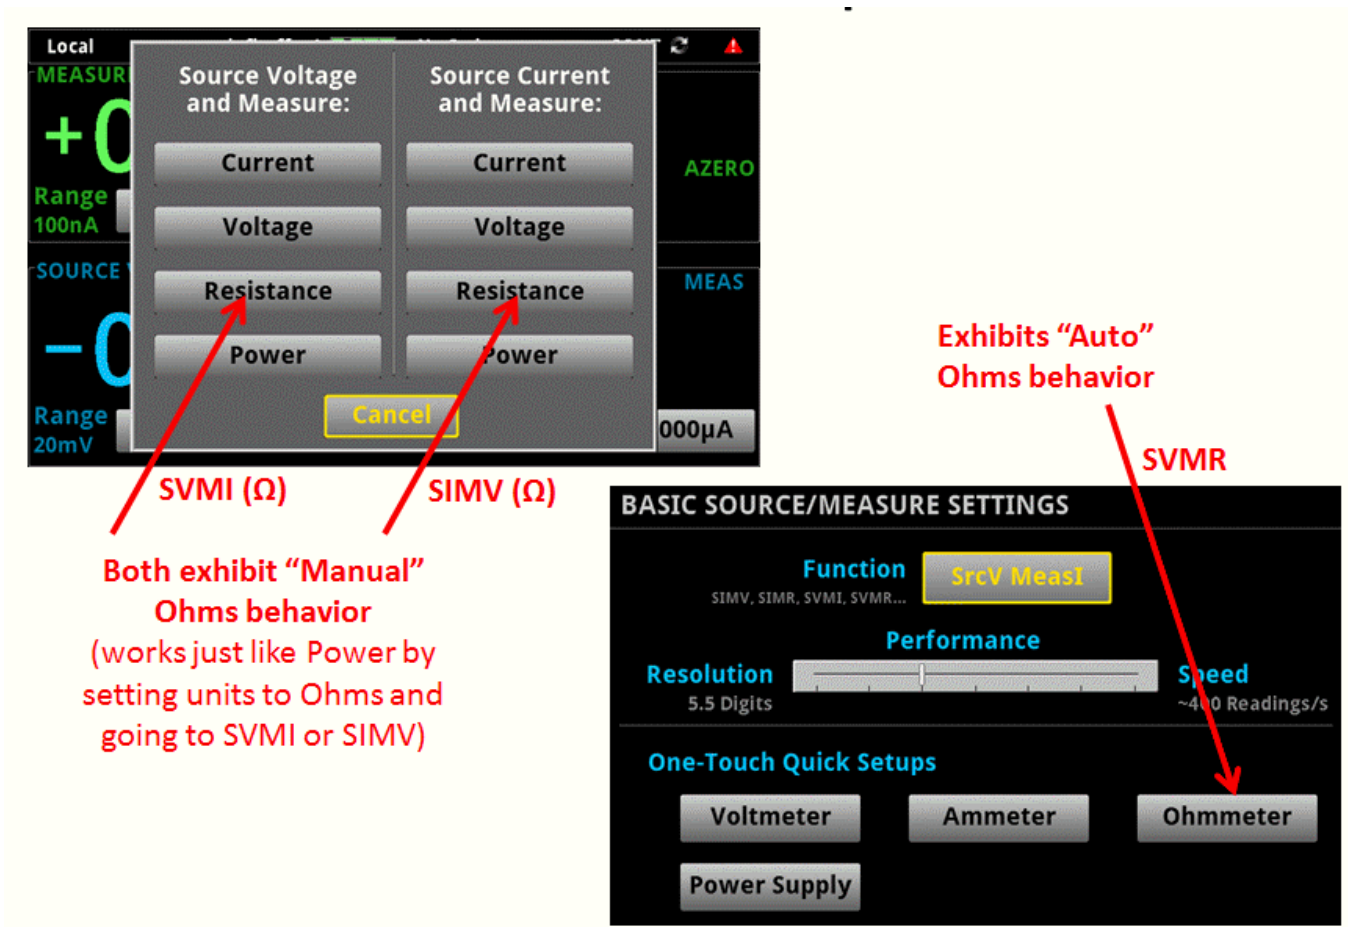
- `smu.measure.func = smu.FUNC_RESISTANCE`
- g. New SCPI Command Usage:
- i. "Manual Ohms" (see definition above)
 - `SOURCE:FUNC VOLTage`
 - `[SENSE[1]]:FUNC "CURRENT"`
 - `[SENSE[1]]:CURRENT:UNIT OHM`OR
 - `SOURCE:FUNC CURRENT`
 - `[SENSE[1]]:FUNC "VOLTage"`
 - `[SENSE[1]]:VOLTage:UNIT OHM`
 - ii. "Auto Ohms" (see definition above)
 - `[SENSE[1]]:FUNC "RESistance"`
- h. Front panel user interface setting of Manual vs. Auto Ohms measurements
- <see the following figure for details>

- `smu.measure.unit = smu.UNIT_OHM`
 - ii. “Auto Ohms” → Measures resistance by sourcing current, measuring voltage, and calculating the resistance reading. In this case, the source current and source limit are automatically calculated and set.
